Slade Brook NFM

Appendix B - NFM walkover assessment.

Draft Technical Note

March 2024

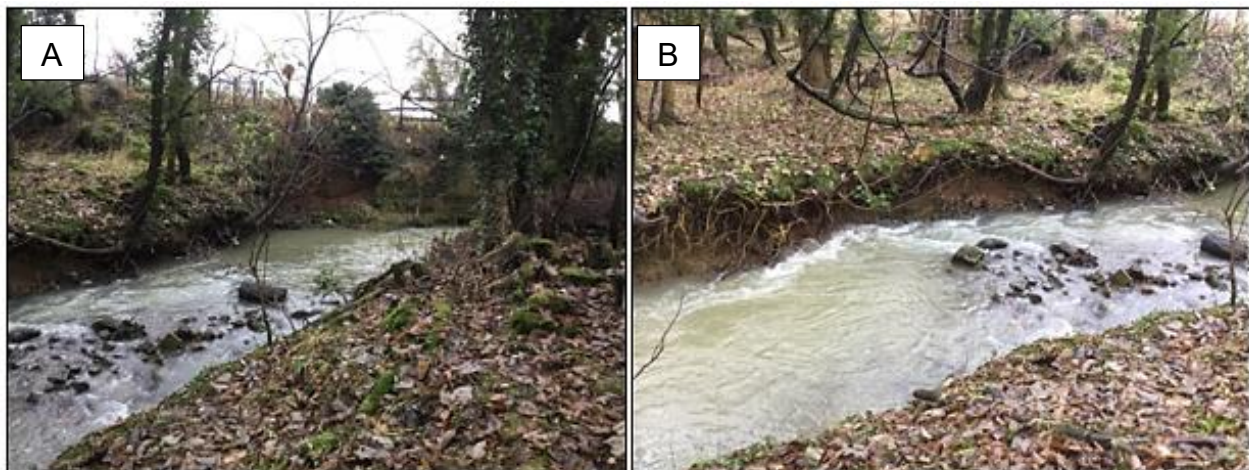
Hard-core debris has been fly-tipped into the Slade Brook from Violet Lane which it located roughly 10 metres downstream of the Violet Lane culvert (Figure 1-6 to Figure 1-7). This material consists of coarse bits of concrete and builders' rubble which is causing erosion of the Violet Lane bank and culvert. It is recommended that this material is removed from the channel as it is not natural and is causing adverse impacts to the watercourse and stability of the Violet Lane banks.

Figure 1-6 Photo location 1, standing on the left bank looking upstream at the Violet Lane culvert (12/12/2023).

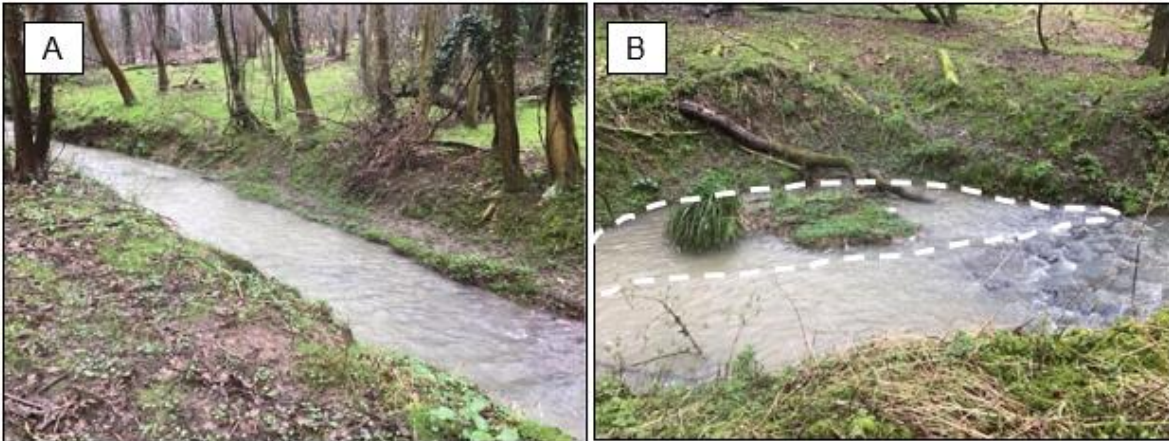
Figure 1-9 Photo location 3, standing on the left bank looking downstream the in channel conditions(12/03/2024). In photo A, the channel is straight but in B the channel appears quite responsive to woody material and a riffle that has developed. The dashed white line indicates the area that has been eroded, slowly increasing the sinuosity and diversity of the channel.

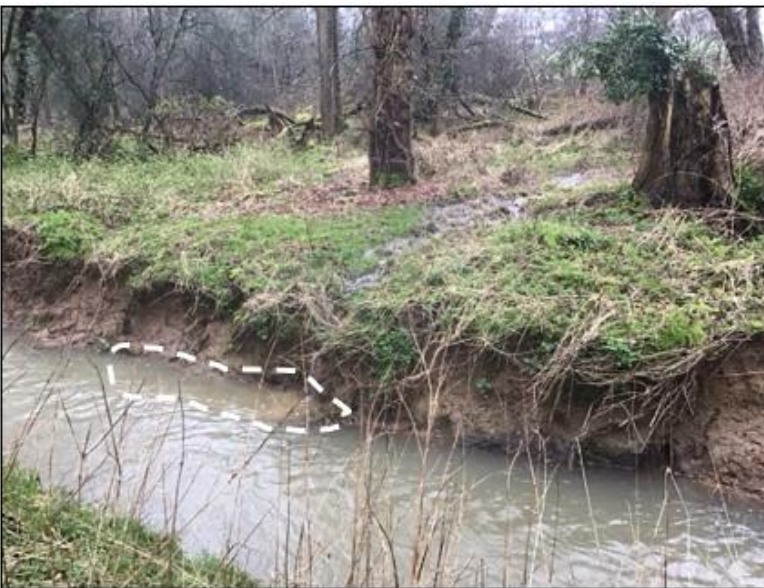
Figure 1-10 Photo location 4, standing on the left bank looking across at a surface water flow entering the Slade Brook (12/03/2024). The dashed white line emphasises the sediment plume being generated by the surface water flow.

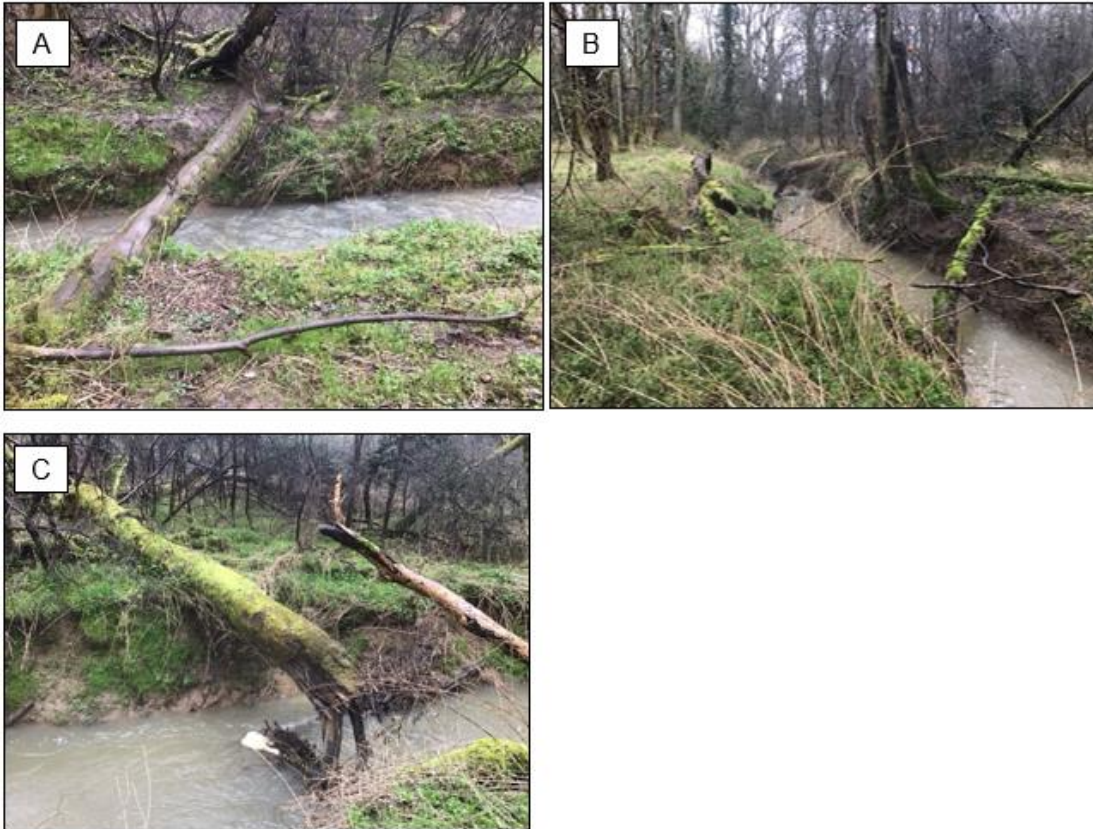
Figure 1-11 Photo location 5, standing on the left bank looking across at a woody debris spanning the channel at multiple locations (12/03/2024)

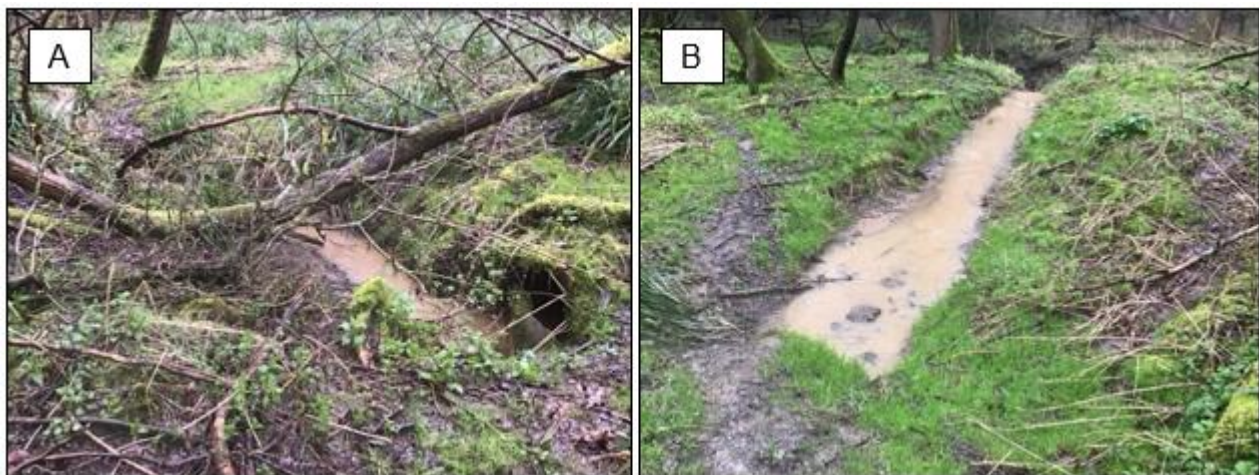
Surface water channels were noted to be freely draining into the Slade Brook. In Figure 1-12 for example, the water is freely draining the floodplain and passes through a culvert before entering the Slade Brook. The water is highly turbid and inputting a significant amount of sediment into the channel. An opportunity exists here to partially block the channel with a leaky barrier/dam to slow the flow and store more water on the floodplain, creating a wet woodland (Photo location 6 - Figure 1-12).

Figure 1-12 Photo location 6, on the left bank looking at a surface water channel draining into the Slade Brook (12/03/2024)

Culvert removal and increase connectivity with floodplain	Removal of culvert on tributary and encourage water to flow through the floodplain (Figure 1-12)	Would need landowner permission.
Block drainage channels	Many surface water channels were noted on site which freely drain into the Slade Brook and had high levels of turbidity, increasing the sediment inputs into the channel.	Investigation required to ensure blocking up the channels will only wet up the floodplain in the woodland and not negatively impact other areas. Would need landowner permission.
Leaky barrier locations	Leaky barrier locations have been located where woody material had naturally accumulated and will seek to enhance these features rather than potentially negatively impacting existing features by installing leaky barriers at other locations.	Consideration in the design required given the likely higher velocities in this location.

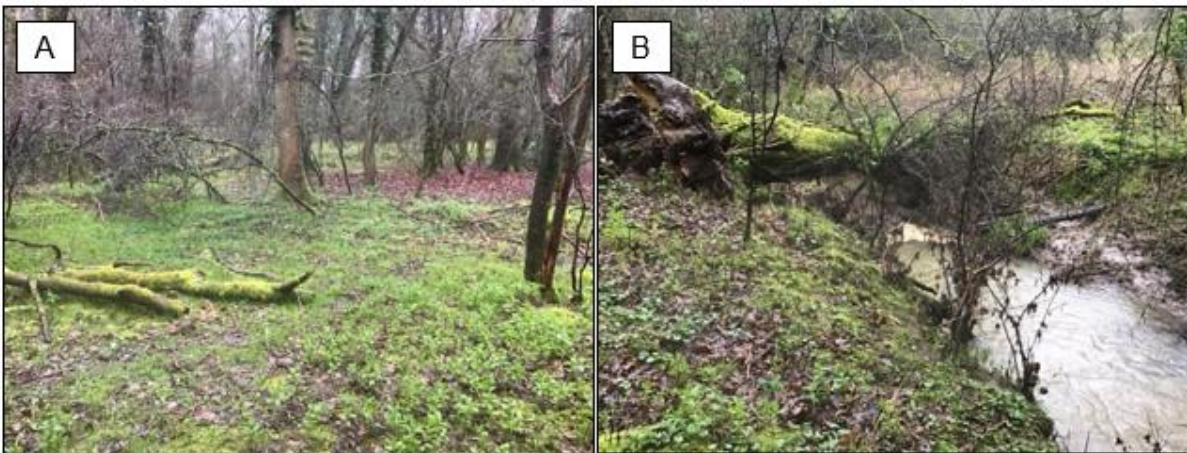
Figure 1-14 Photo location 7, on the left bank looking at the conditions of the floodplain and a natural woody debris dam that has formed in the channel (12/03/2024)

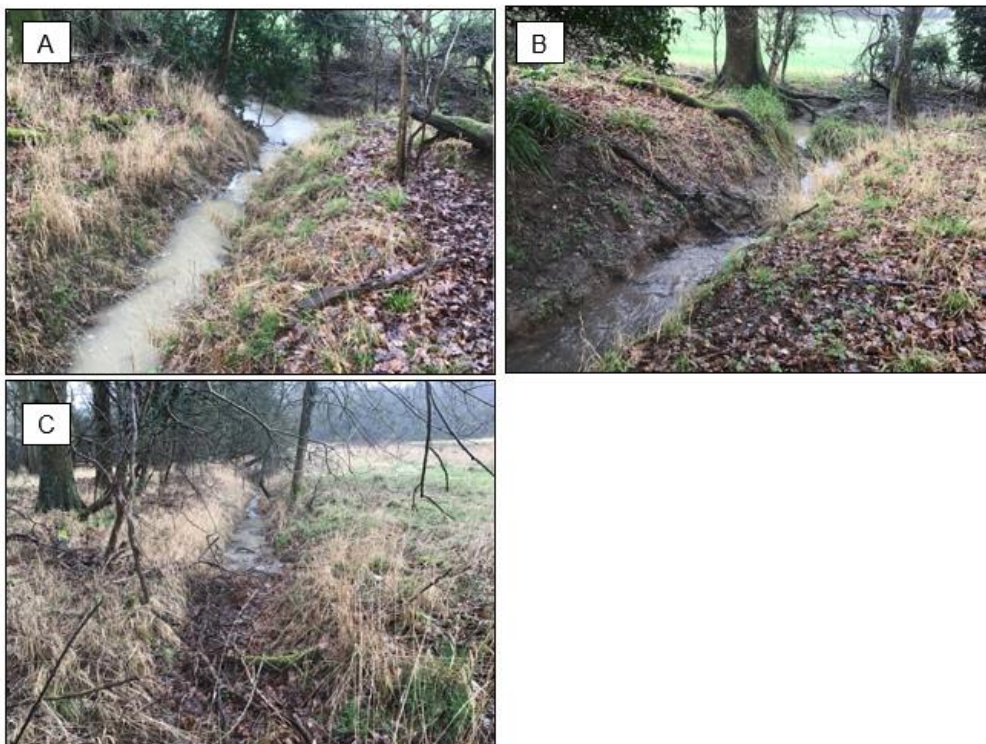
Figure 1-17 Photo location 10, on the left bank looking at a surface water channels draining into the Slade Brook (12/03/2024). Photos B and C show, B) downstream at the confluence with the Slade Brook and C) upstream where there is a blockage of natural debris in the drainage channel.

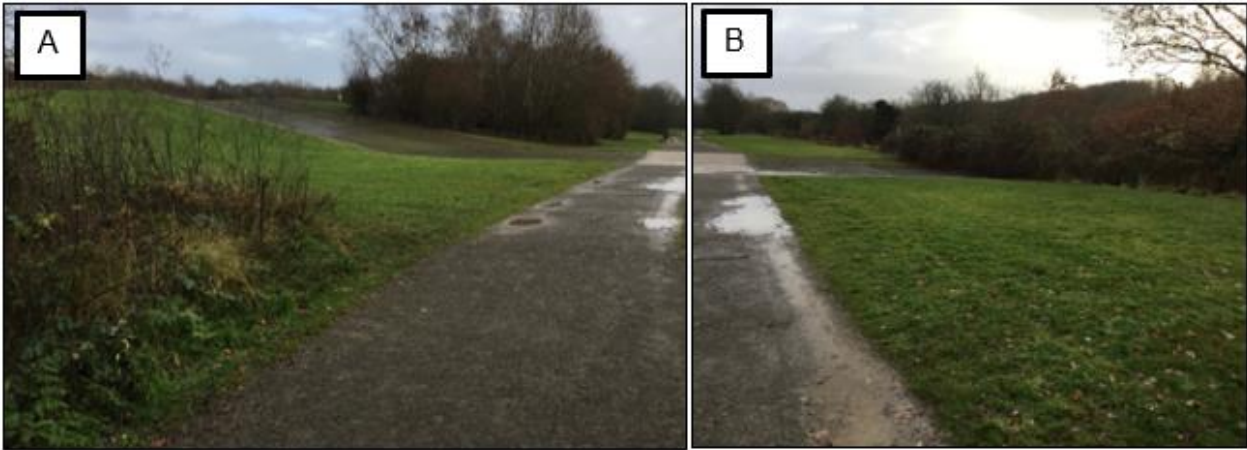
Figure 1-21 Photo location 3, this photo was taken on the path of the left bank, the Slade Brook is in the tree line on the right of this photo (12/12/2023). An overspill from the Prologis Industrial Estate balancing pond is seen crossing this footpath.

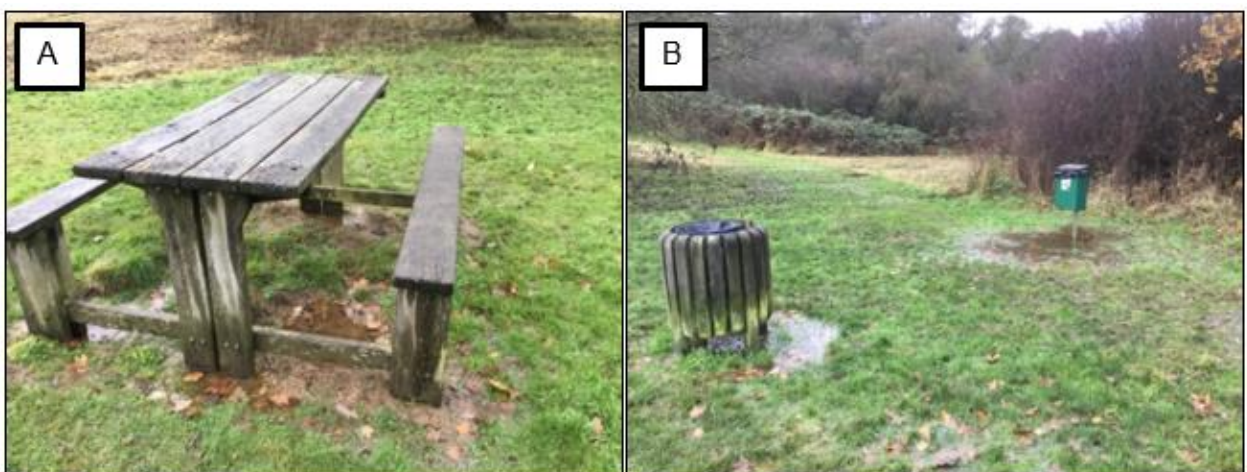
Figure 1-23 Photo location 5, water logged conditions on the right bank of the Slade Brook (12/12/2023)

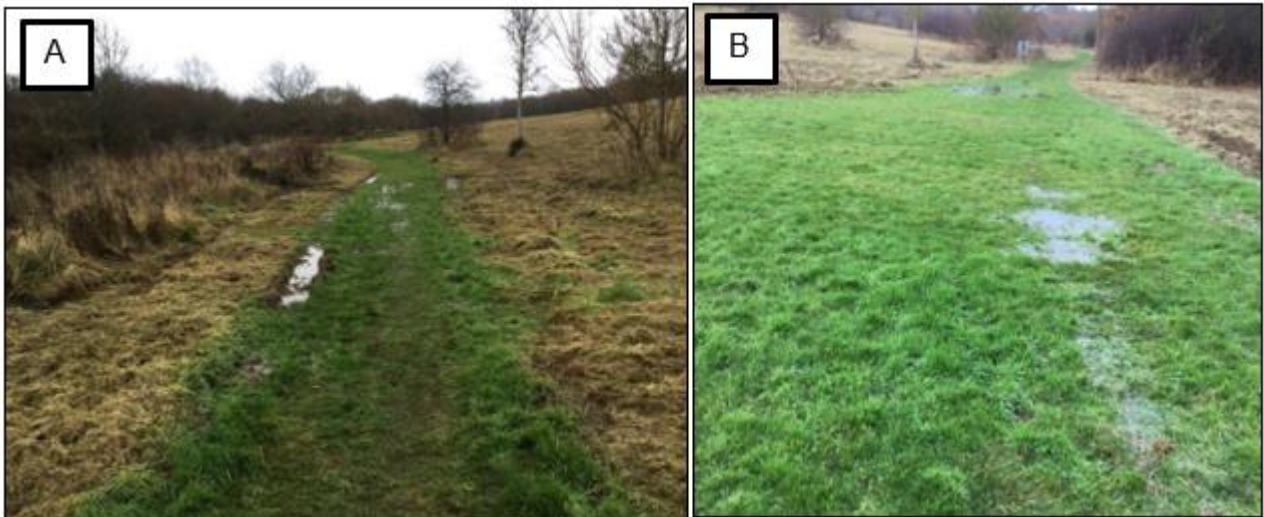
Figure 1-25 Photo location 7, water logged conditions on the right bank of the Slade Brook (12/12/2023)

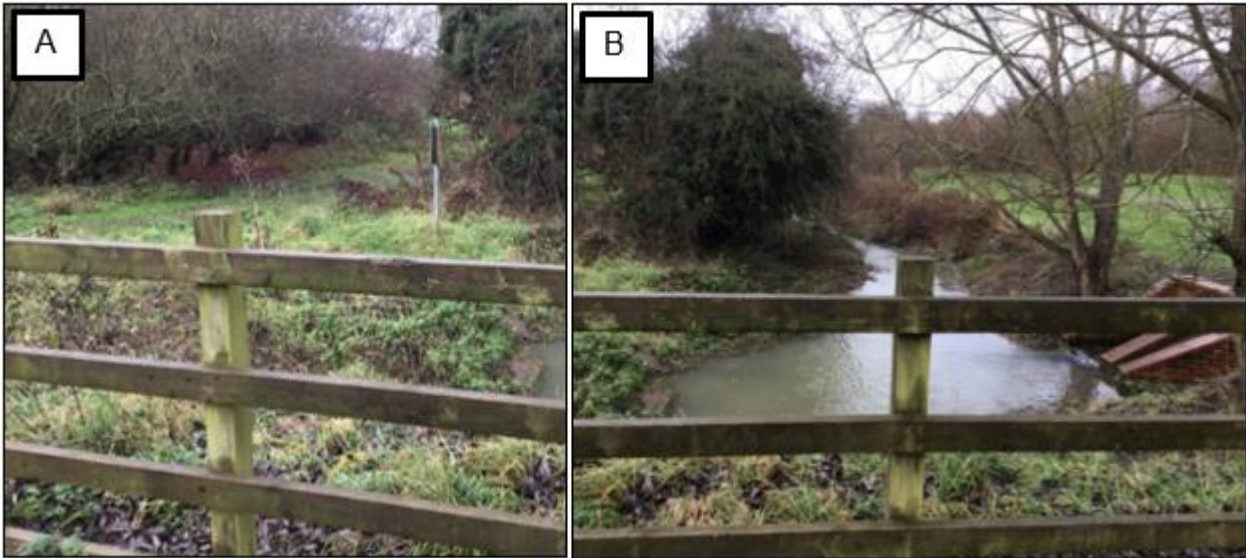
Figure 1-26 Photo location 8, on a bridge looking upstream at Slade Brook and the outfall on the left bank (right of photo). The conditions were waterlogged on the right bank and there is a tarmac footpath on the left bank (12/12/2023)

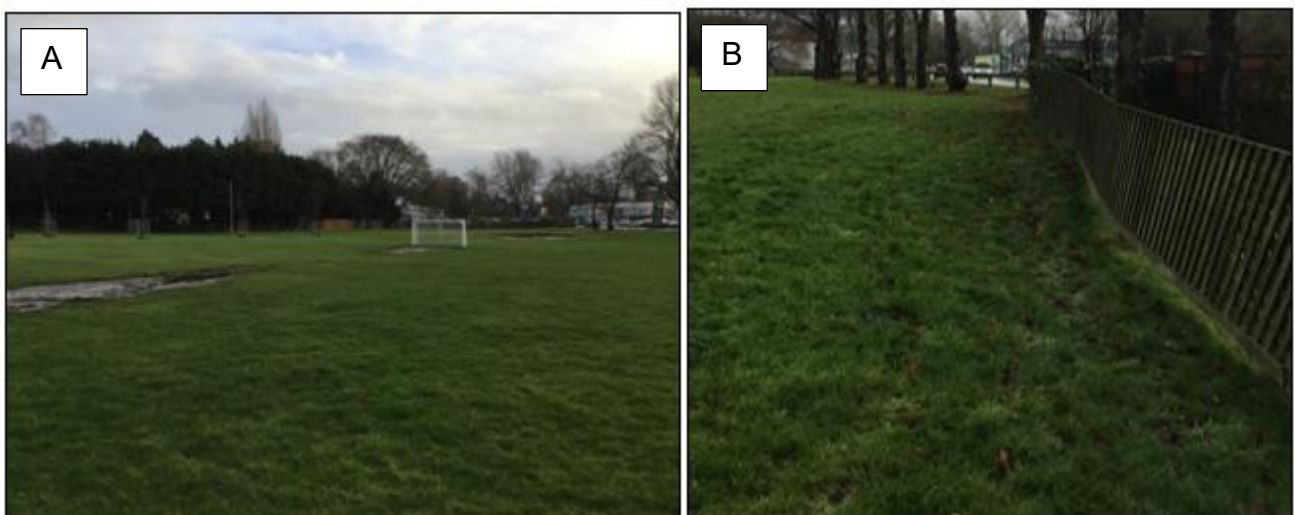
Figure 1-30 Facing southeast of the field at the waterlogged conditions at Meadow Road A) Standing on the left bank of the Slade Brook at Meadow Road Park. B) The Slade Brook is to the right of the fence where a culvert or outfall is situated under the ground.

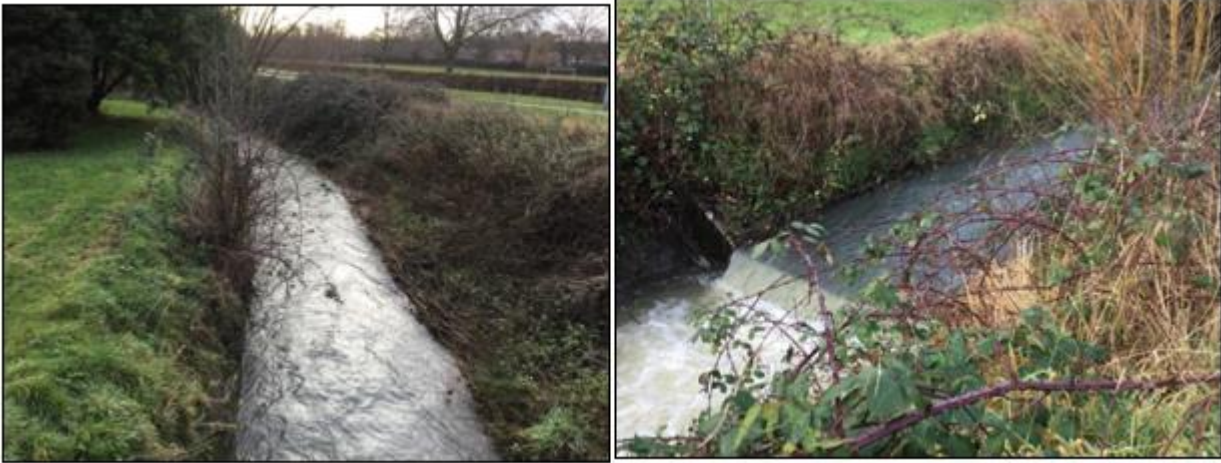
Figure 1-32 Looking downstream at Slade Brook (Left) looking upstream (right) at a raised feature (possibly weir) in the Slade Brook

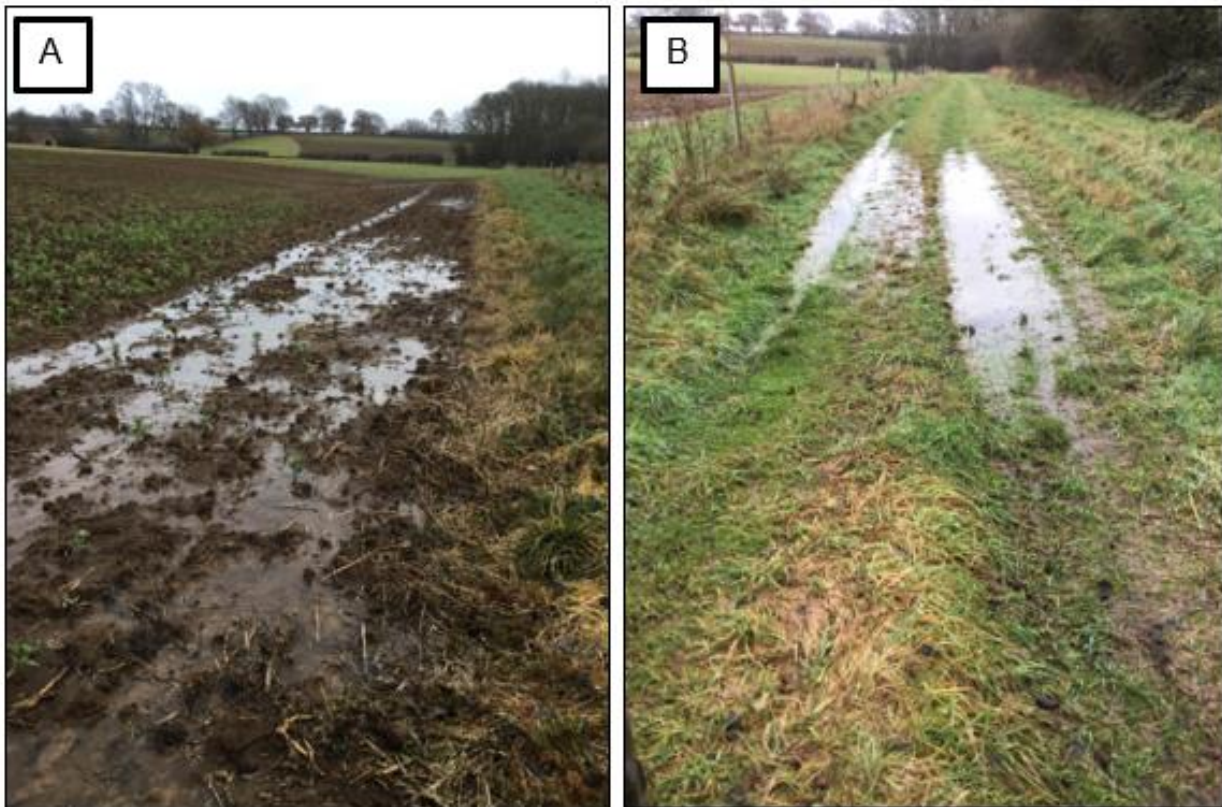
The conditions within the valley floor were wet, with waterlogged locations on the farm track (Figure 1-37 to Figure 1-38) which was likely increased due the presence of a spring. Springs are typical in this Northamptonshire landscape (Northampton Sand Formation) due to the Jurassic Oolite bedrock groups and where the aquifer intersects ground surface. This spring being ploughed and part of the arable field was likely increasing sediment connectivity to the watercourse as sediment movement (erosion and deposition) was visible within the wetted area.

Figure 1-38 Extent of the wet conditions caused by the spring on the left bank.

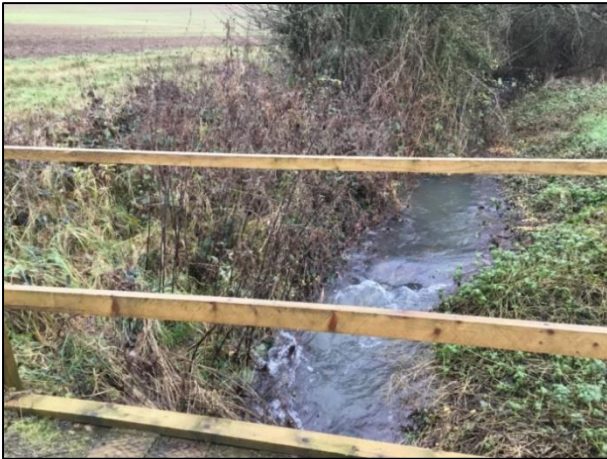
Figure 1-39 Flow conditions at the downstream extent of the proposed restoration site. The flow appears faster with heavier discharge which could be the result of the drainage from the adjacent fields.

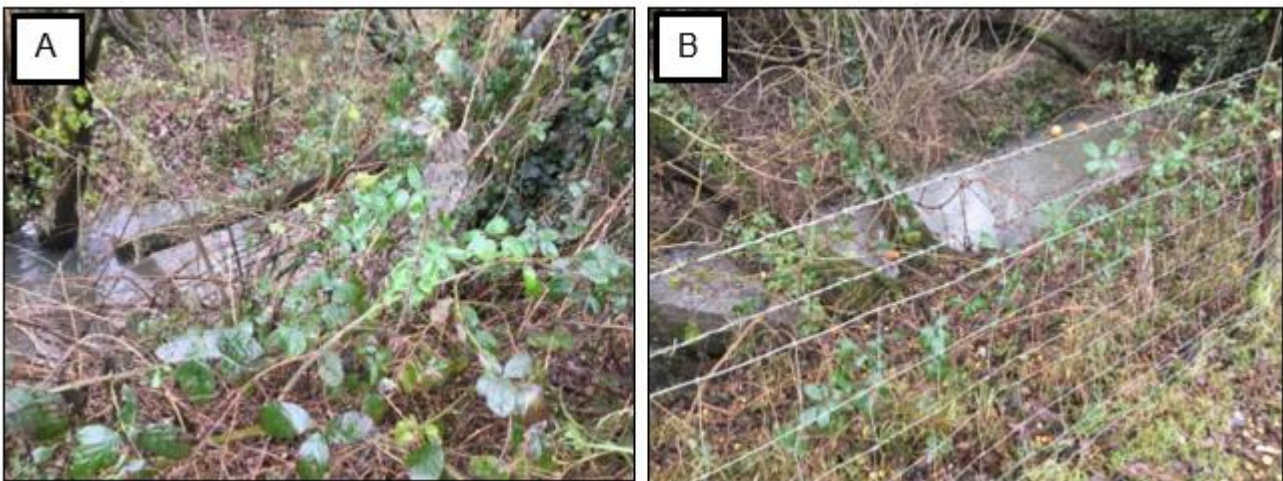
Figure 1-43 On the left bank looking at the watercourse which is within a wooded corridor. The watercourse is lined with both mature trees and scrub but is potentially overshadowed. A) Woody material was allowed to accumulate within the channel, B) the channel is straightened and the water appears turbid, the riverbed was not visible

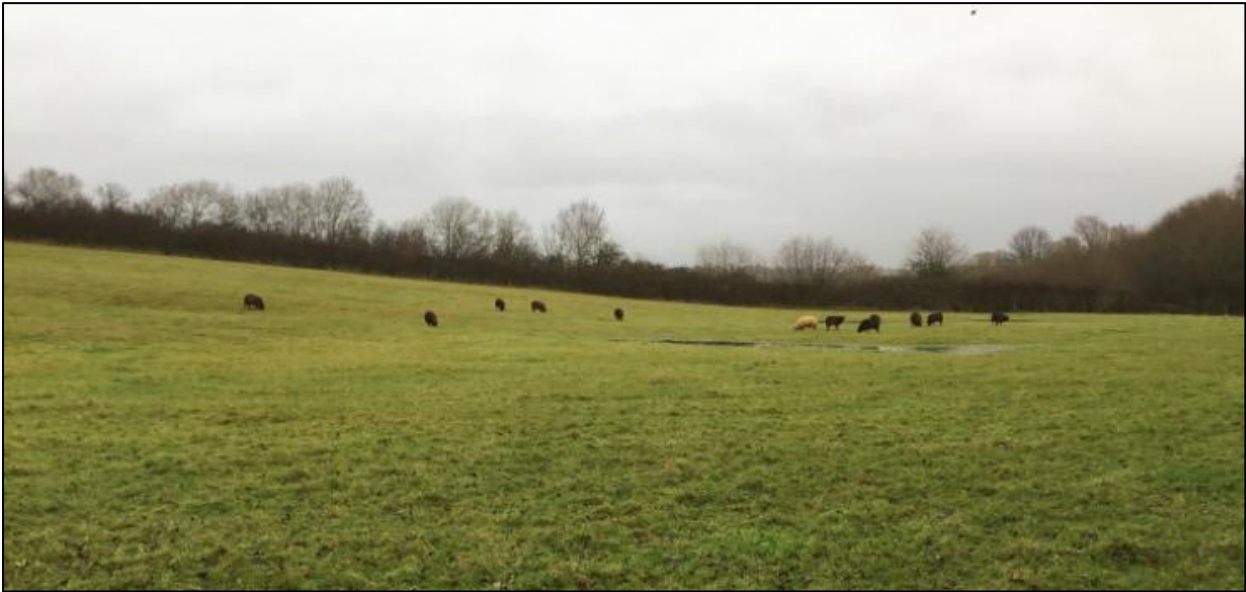
Figure 1-44 There are paleochannels visible on the floodplain on the left bank. These paleochannels are already holding surface water and showing the waterlogged conditions of this field

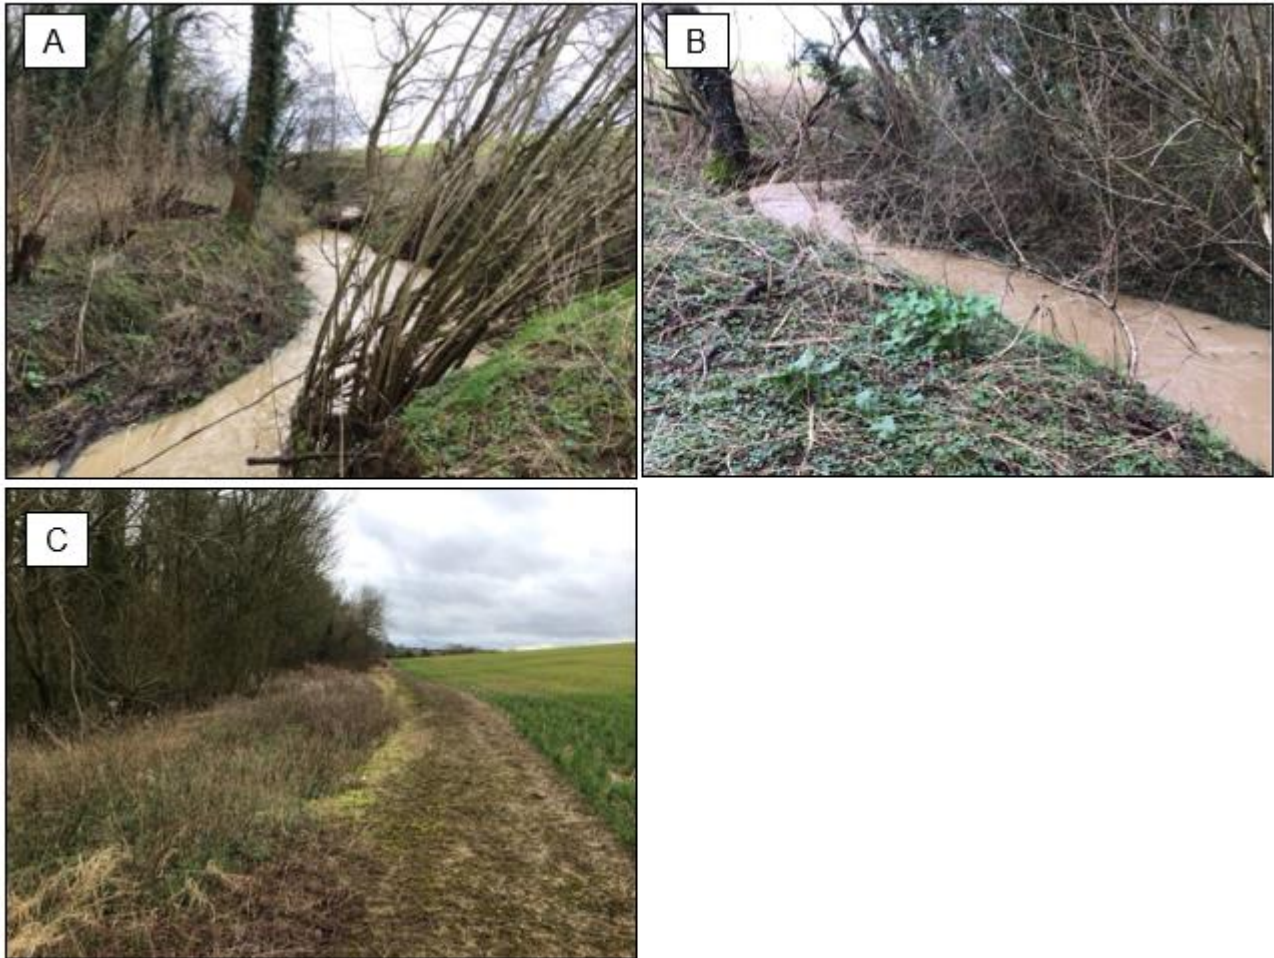
Figure 1-48 Standing upstream on the left bank A) looking upstream, B) looking downstream and C) at the land on the left bank (12/03/2024). The Copicemoor Brook at this location is heavily turbid with significant amount of sediment suspended in the water.

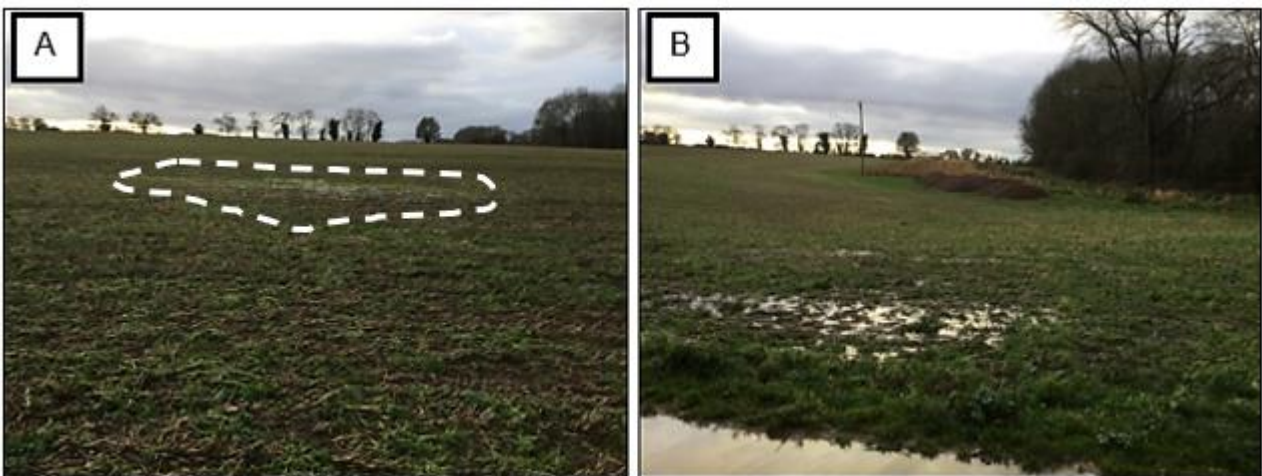
Figure 1-53 Despite the steepness of the hillslope, the hill is retaining water in lower reliefs, B) also shows mounds of soil and a potential mitigation field buffer close to the brook (12/12/2023)

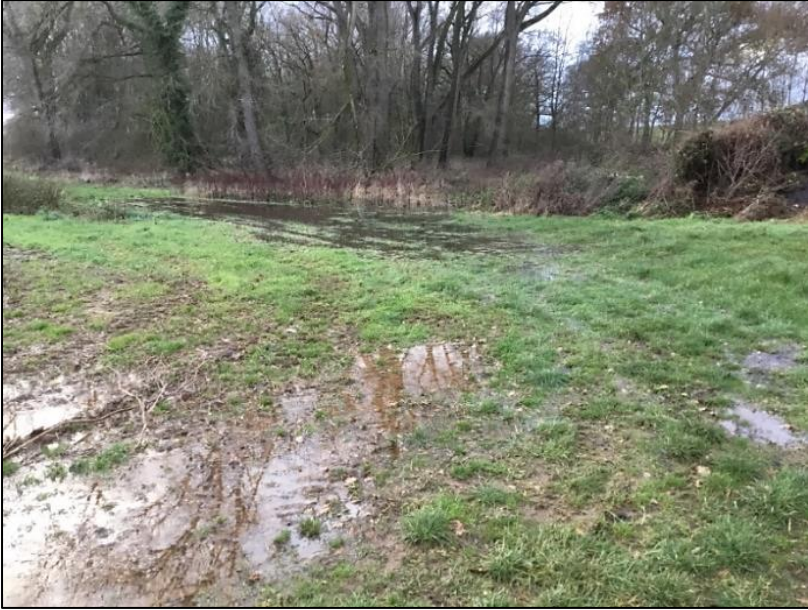
Figure 1-54 Waterlogged conditions on the site on the right bank of the brook (12/12/2023)

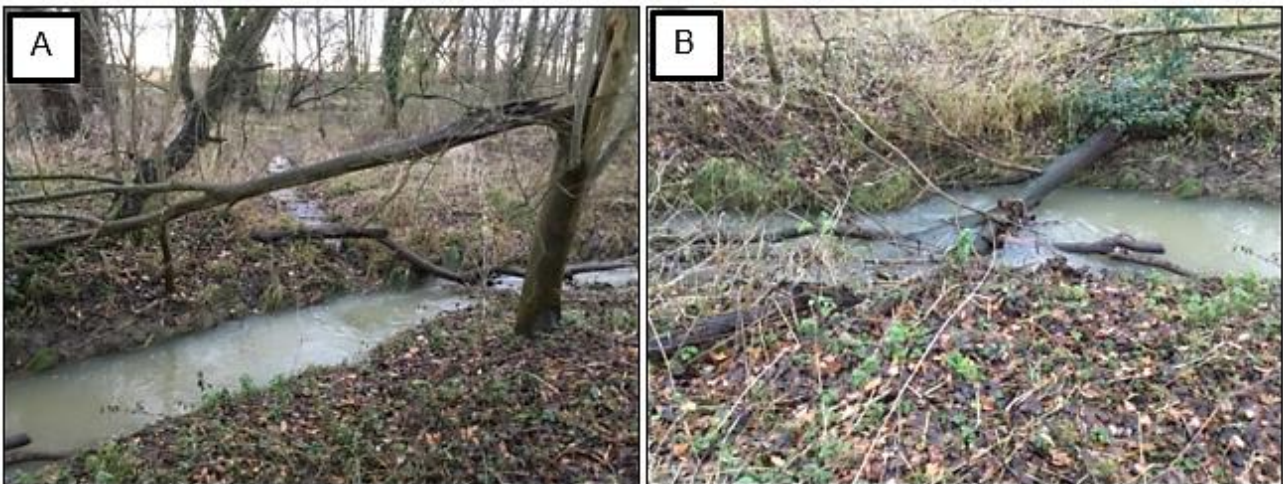
Figure 1-55 Standing on the left bank looking across A) to a tributary on the right bank and B) at fallen woody debris in the channel which is causing localised erosion and morphological improvements to the channel (12/12/2023)

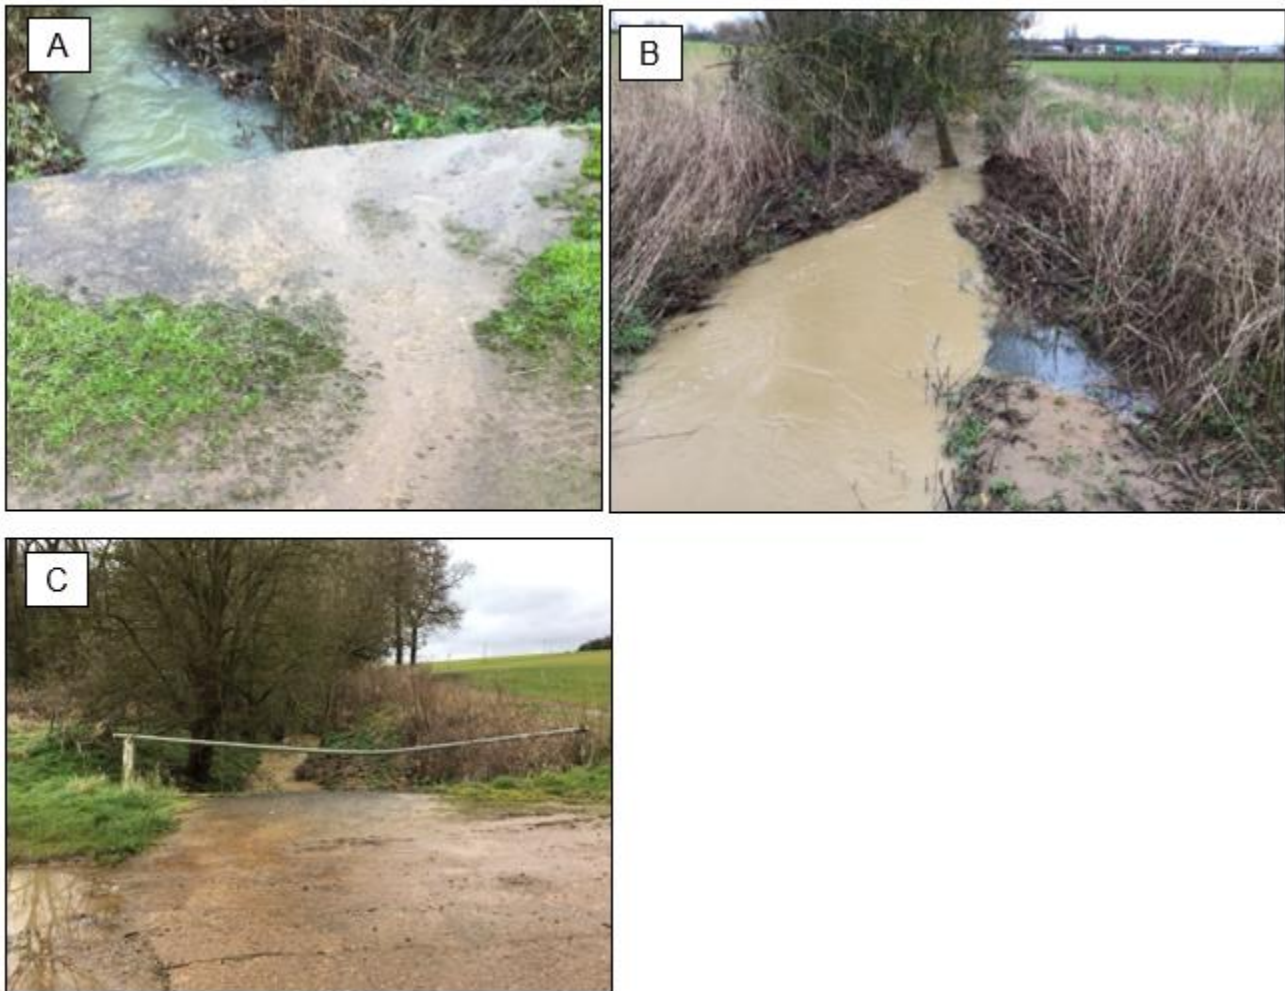
Figure 1-58 Standing on the bridge looking A) downstream (12/12/2023), B) downstream (12/03/2024) and C) upstream with a wider view of the bridge/culvert (12/03/2024). A sediment pathway connects the farm track to the Copicemoor Brook which likely introduces excess sediment into the channel.

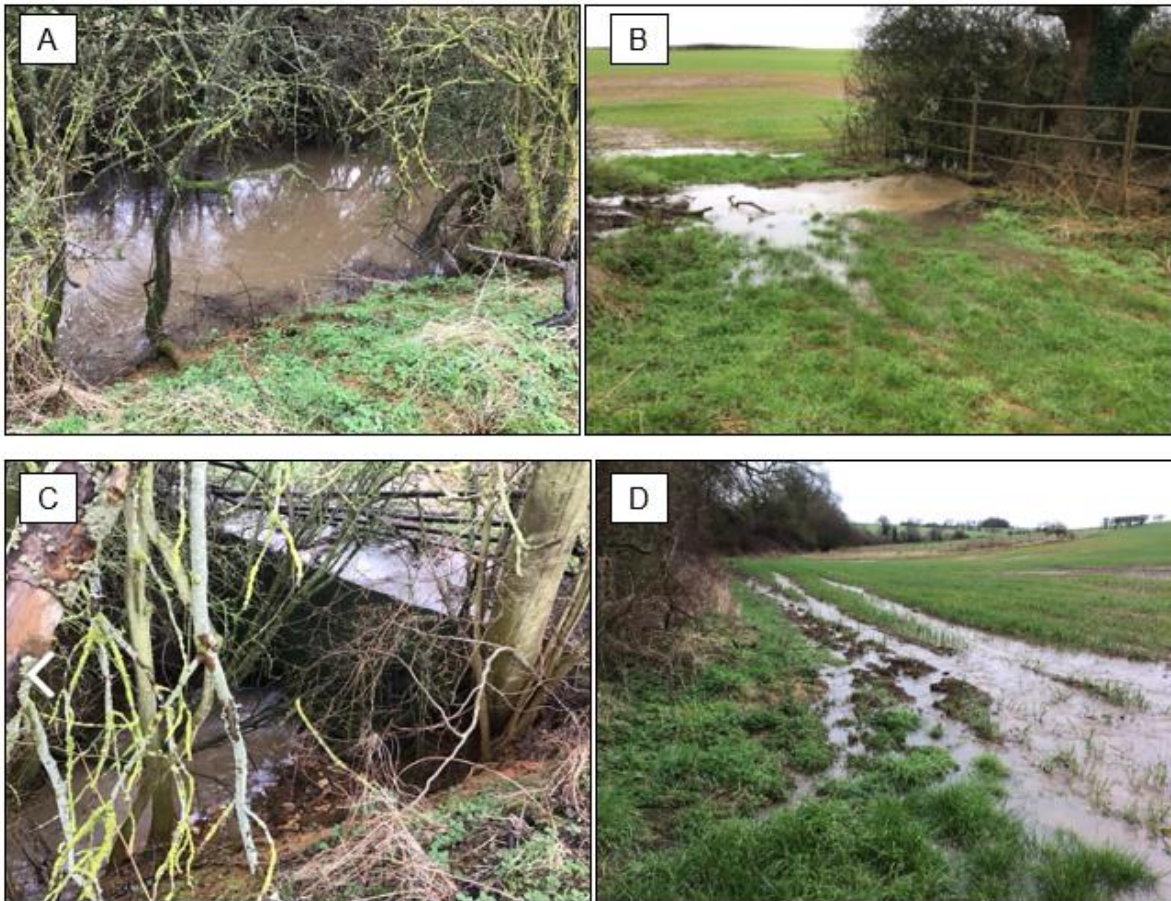
Figure 1-60 On the left bank of a field drain looking at A) the impounded flow of the channel, B) the field access culvert which is being overtopped by the impounded flow, C) the culvert outfall where the flow is significantly constricted but some flow is coming through and D) the flow path of the water that has overtopped the structure and flowing down the valley.

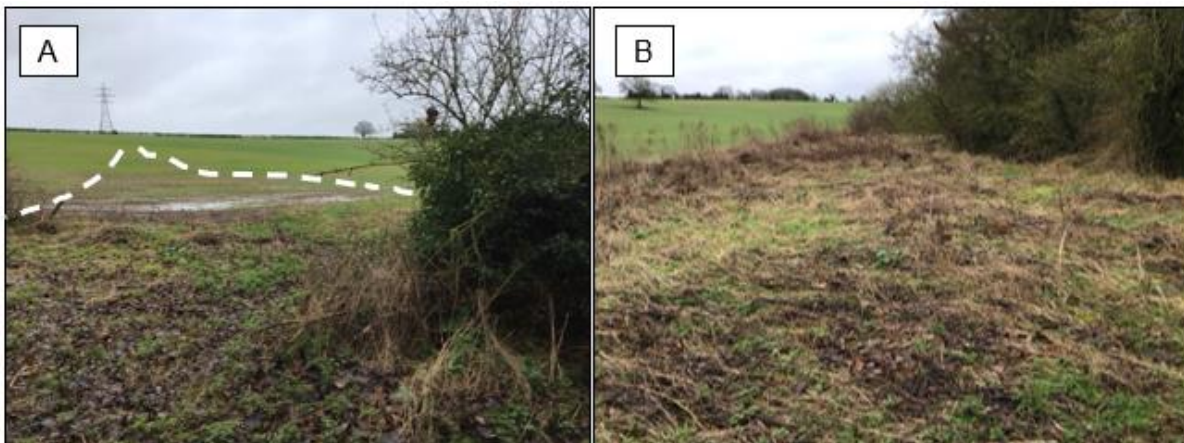
Figure 1-63 on the left bank of the Copicemoor Brook looking at the buffer margin and conditions of the arable field. In photo A) areas of water retention can be seen in the undulating valley reliefs (white dotted line), and B) the width of the buffer strip can be seen which covers approximately 15 - 20m from the field edge to the brook.

Opportunity	Description	Constraints
Widen the buffer strips	There is not much space between the arable fields and the brook. It is recommended to create more space and allow for natural processes and NFM interventions to be installed in the brook. Could generate BNG and ELMs benefits.	Requires landowner engagement.
In-channel improvements	Install in-channel improvements: <ul style="list-style-type: none"> • Pool riffle sequence, • Woody debris, • Berm features. 	Requires landowner engagement.
Increase space for water laterally	The channel is confined within a narrow trapezoidal and straightened channel with limited space for natural processes. Potential to widen the space 10 - 20m. This opportunity could also help retain a small amount flood waters and help to slow the flow.	Requires landowner engagement.
Wetland creation	Due to the blocked culvert, the brook is already connected to the floodplain. This should be further encouraged and to maximise the benefits and ecological potential of the wetland. Could generate BNG and ELMs benefits.	Requires landowner engagement.

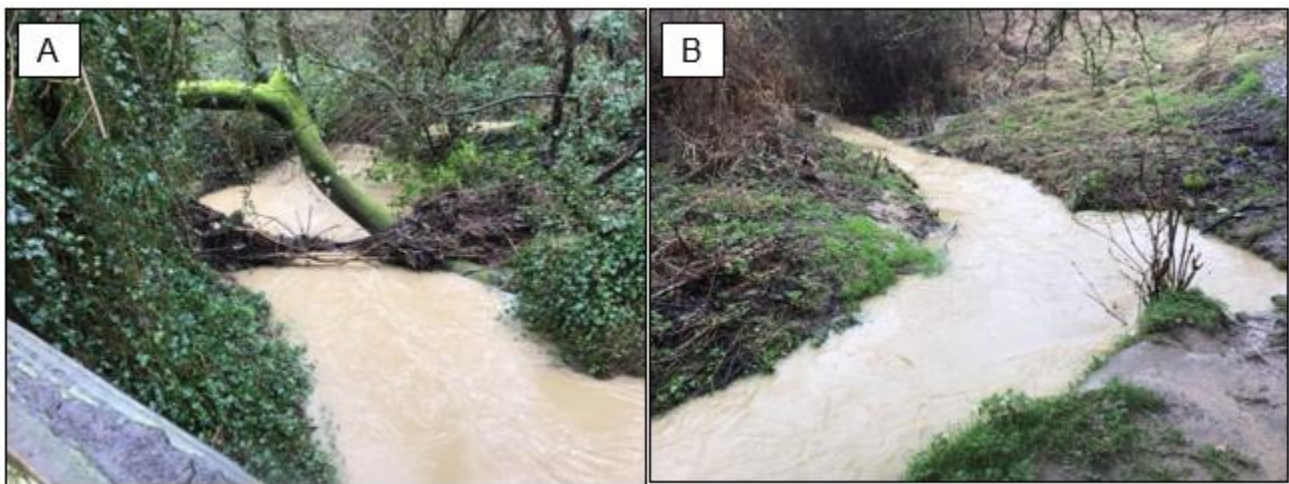
Figure 1-66 Standing on the bridleway footbridge looking at the Coppicemoor Brook A) upstream and B) downstream.

Some natural bank protection may need consideration by the footbridge to prevent further erosion that is currently being caused by the volume and flow of water moving through this section of the brook (Figure 1-66). To allow the riparian zone to develop, crown thinning is suggested in this area that will reinforce the stability of the bank and reduce erosion. Willow spiling could also be utilised to support the bank and protect from erosion. Additionally, the vegetation by the brook is mostly comprised of horsetails and nettles, and would have no particular maintenance requirements, however some yearly monitoring may be suitable.

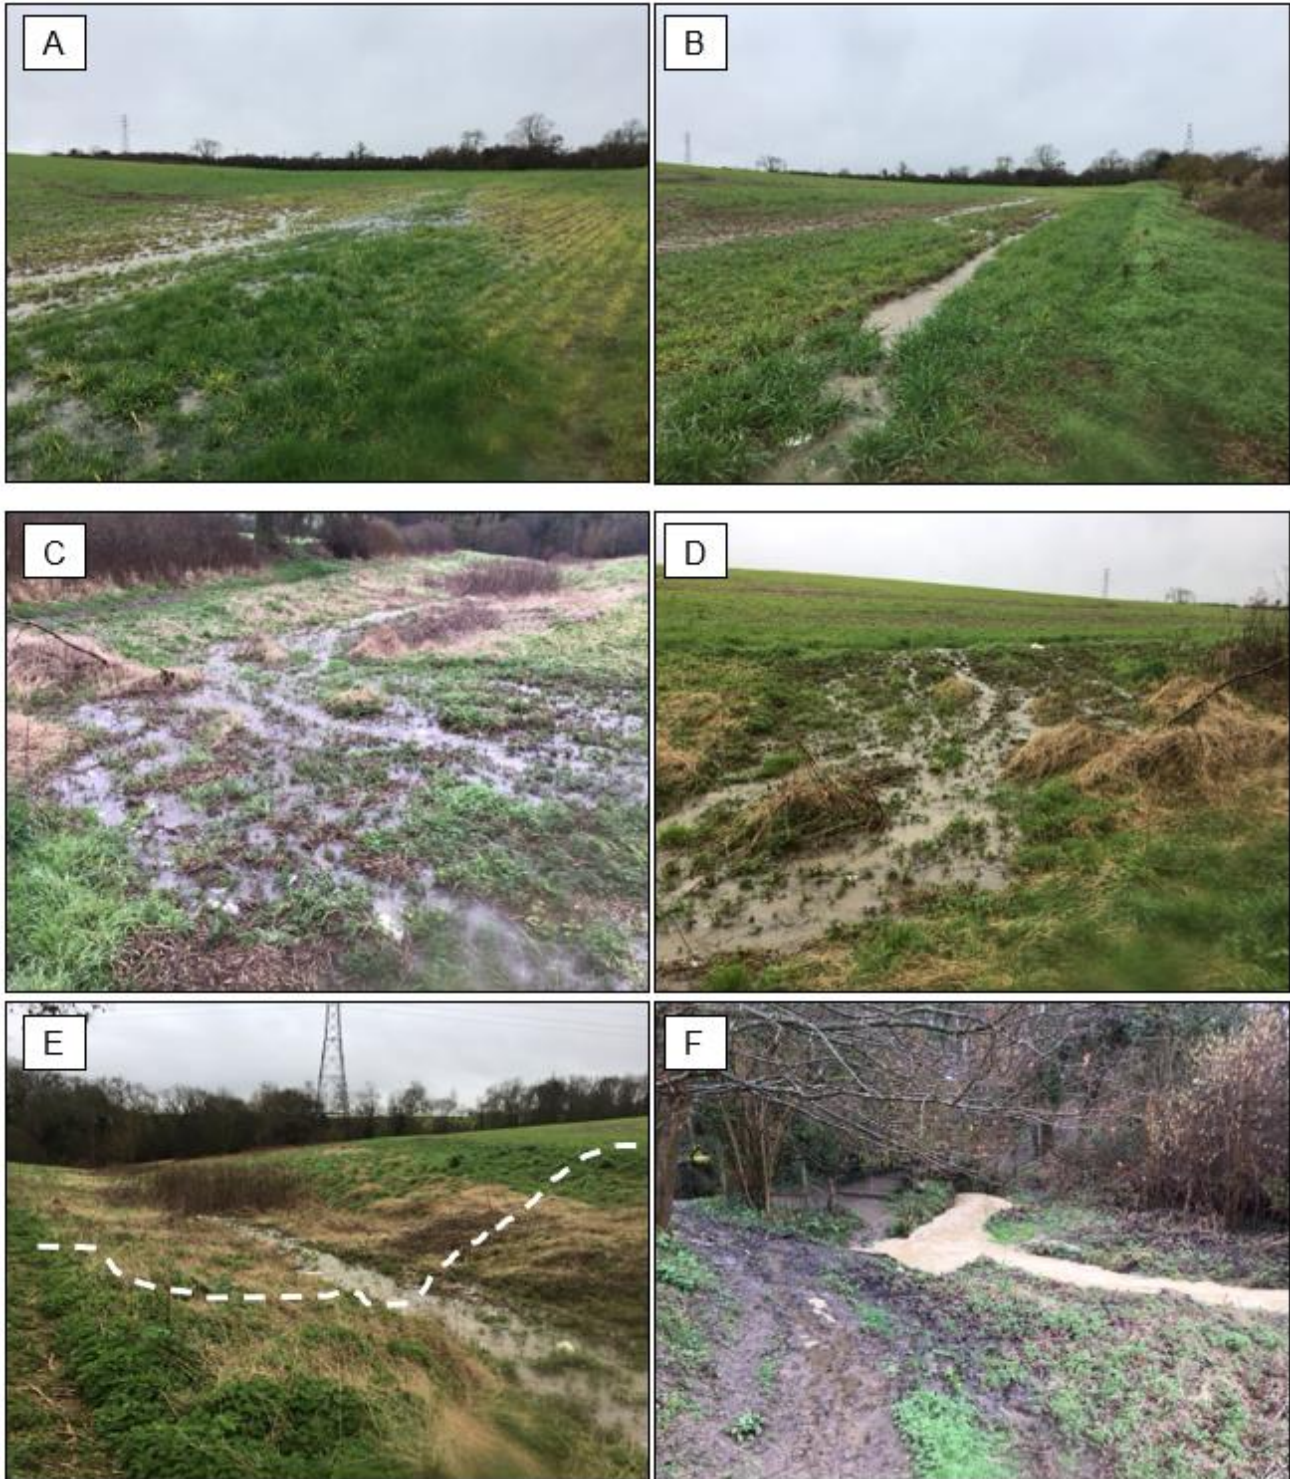
Figure 1-67 A) Photo location 2, A surface water flow originates in this arable field, B) the flow runs along the edge of the arable field, C, D) the flow becomes braided and exits the arable field, E) the flow enters a concave relief in the valley slope (white dotted line to show the concave relief channel) and F) the flow enters the Coppicemoor Brook.

Between fields are established hedgerows which are causing water to pool and move north easterly towards the end of the hedgerows before continuing downslope across the agricultural field towards the watercourse (Figure 1-67). There is some damage to the hedgerows from livestock, fencing them off to prevent grazing should be considered as

Opportunity	Description	Constraints
Expand and improve the swale	In Figure 1-67 a surface water flow originates in an arable field. It is currently unregulated and generates fast flows and sediment into the Slade Brook. To reduce negative impacts and improve the flow for NFM, it is recommended that the area where this flow exists is converted into rough grassland for a swale. Within this swale there should be added roughness and woody material installed to slow the flow and provide areas for sediment deposition. Could generate BNG and ELMs benefits.	Requires landowner engagement.
Bridleway improvements	In Figure 1-68 a bridleway has become significantly poached and is generating a lot of sediment which can easily be washed into the Slade Brook. It also provides poor access for the path users. It is recommended that improvements are sought to reduce the poaching of the path. This could be the instalment of a sturdy pathway material that is suitable for a bridleway.	Requires landowner engagement.
