Slade Brook NFM

Appendix B - NFM walkover assessment.

Draft Technical Note

March 2024

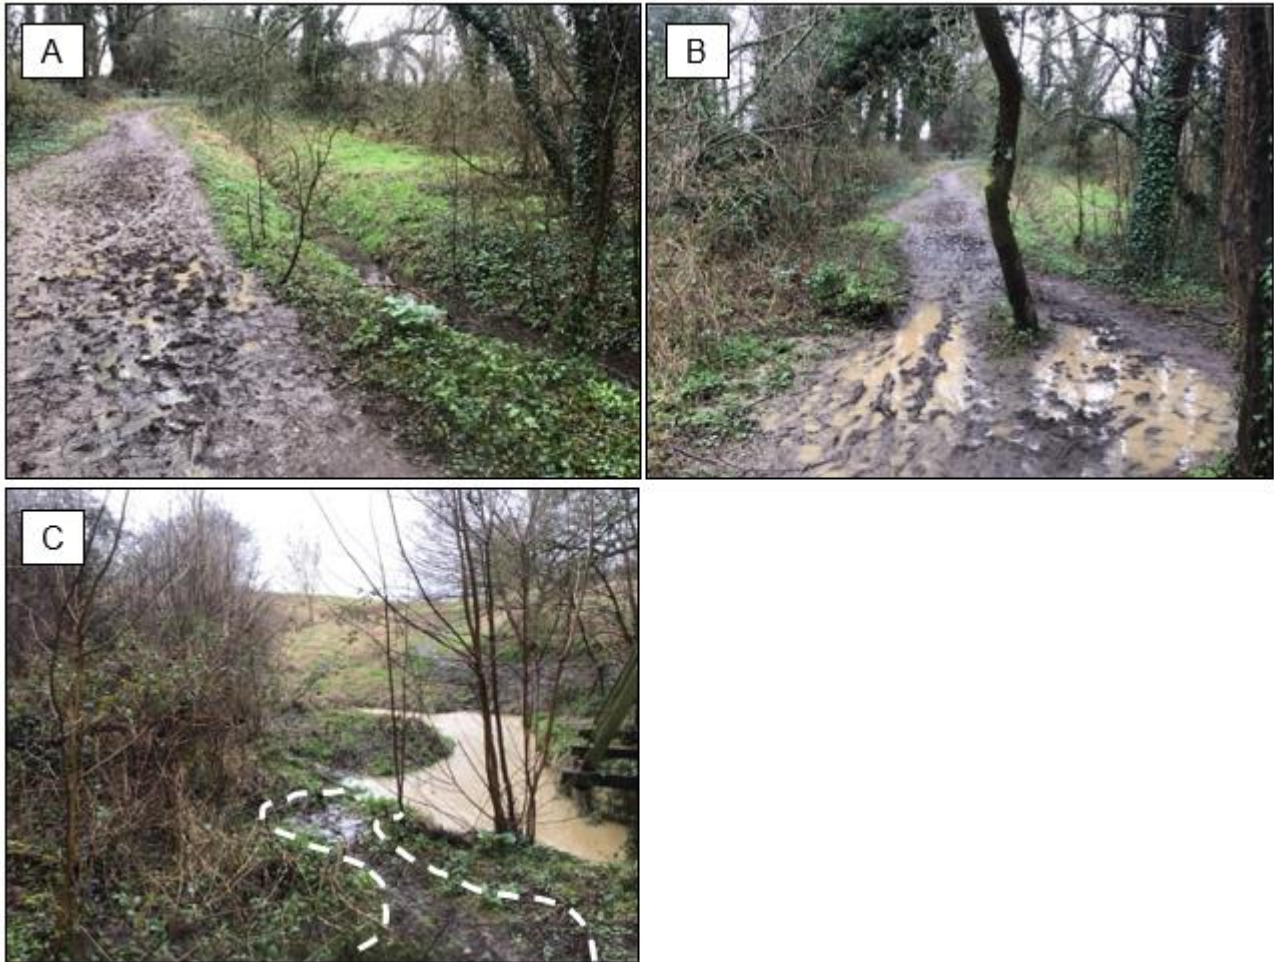
Figure 1-68 Photo location 3, a bridleway crosses the Copicemoor Brook A) on the right bank where a drain flows alongside the bridleway, B) the poached and ponded conditions of the bridleway and C) the drain entering the Copicemoor Brook (white dotted line to show the drainage).

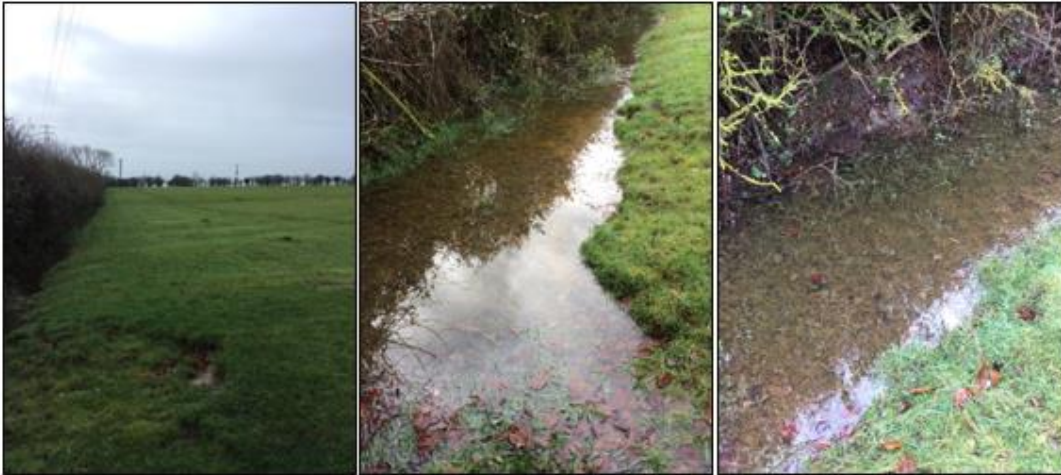
Figure 1-69 Improved grassland field with ridge and furrow features (left) causing water to pool in front of hedgerow (right)

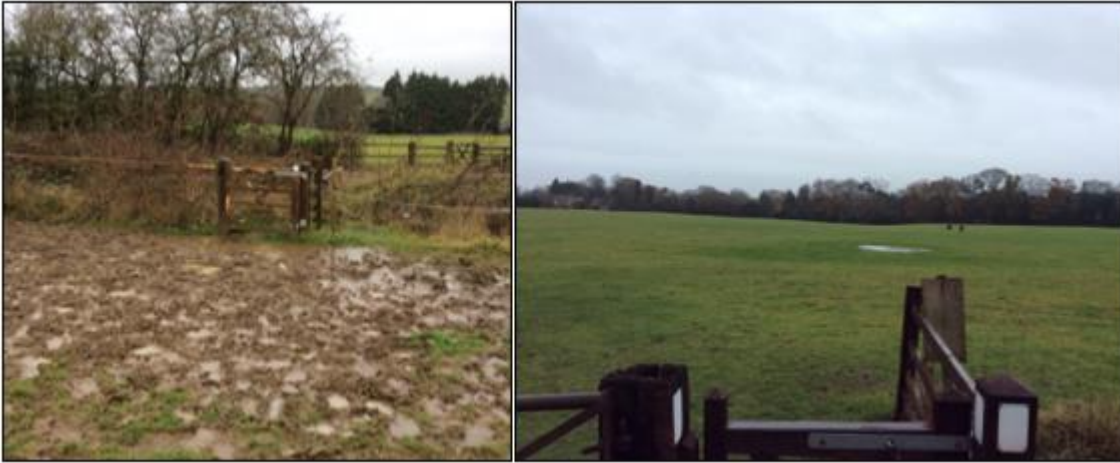
Great Cransley is to the north of Broughton and the west of Loddington Road. Figure 2-3 shows two different improved grassland areas where the soil has been compacted by the horses kept in the fields. The topography of the land could be used to establish wetland vegetation and create ponds to store water in high rainfall events. Fencing areas off to promote vegetation growth at the lowest points could slow the flow of water (Figure 2-3). Soil improvements will increase infiltration capability of the soil and footpath improvements would reduce poaching along the currently suggested public footpath and would encourage users to stick to a more direct route across the field. These conditions were evident across the majority of the upper catchment areas visited by the survey team.

Figure 2-3 Two fields showing the effects of horses compacting and trampling the soil.

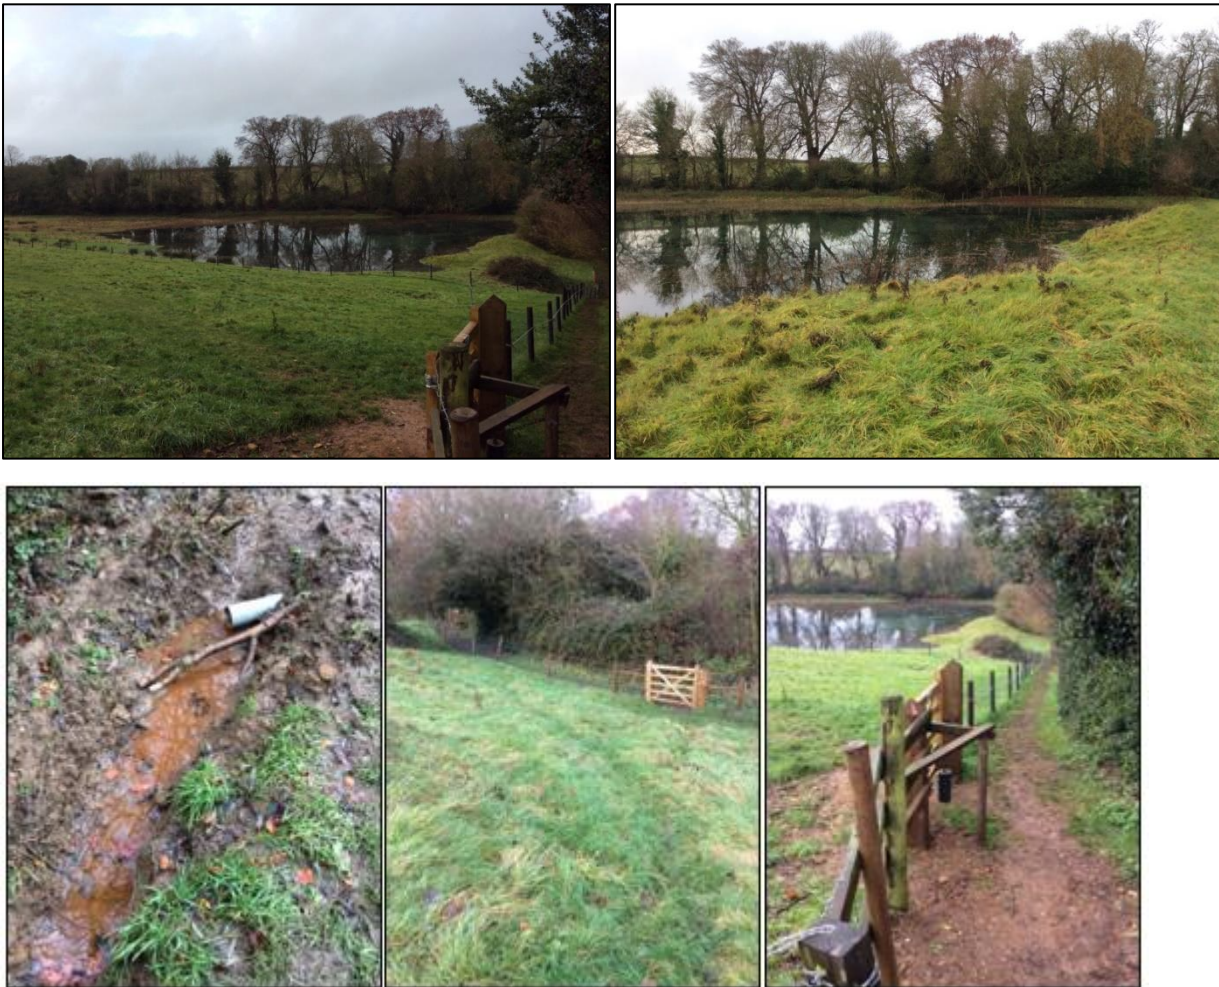
Figure 2-10 Large storage area with bund, further investigation required.

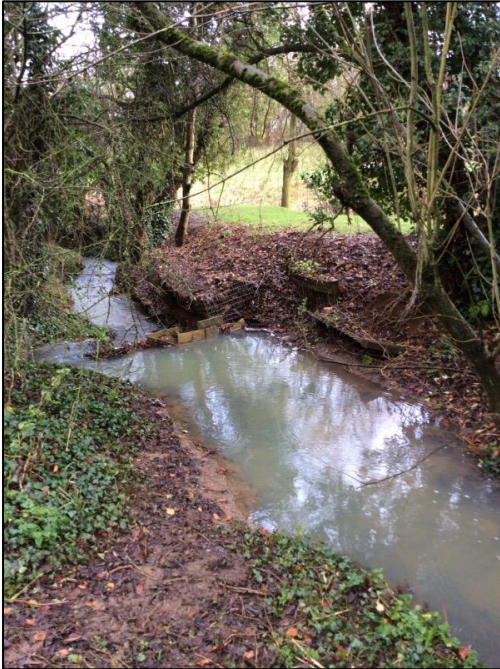
Figure 2-11 Informal barrier in watercourse, further investigation required
