Slade Brook NFM

Natural Flood Management Feasibility Report

Draft Report

March 2024

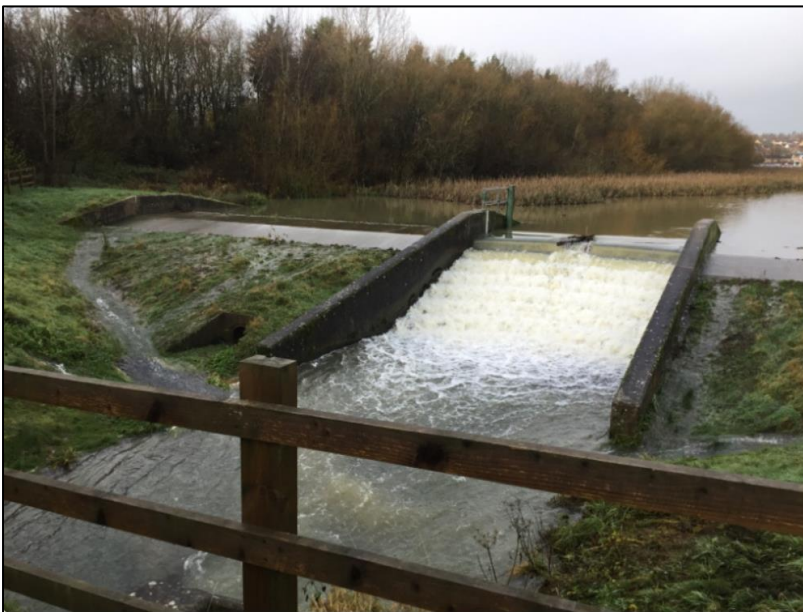
Figure 2-2 The dam impounding the flow of the Slade Brook at Kettering Conference Centre for a wildlife lake.

Large waterbodies can be found in the Slade Brook and Ise catchments. In the downstream reach of the Slade Brook, there is a wildlife lake next to Kettering Conference Centre, also locally known as Kettering Leisure Village. This lake is created by a large concrete dam, Figure 2-2, which impounds the flow upstream. The lake is beginning to succeed as the sediment is trapped behind the dam. The flow can vary and is responsive to flood events as the dam level is constant and the flow overtops the dam. However, this is likely depriving downstream reaches of sediment.

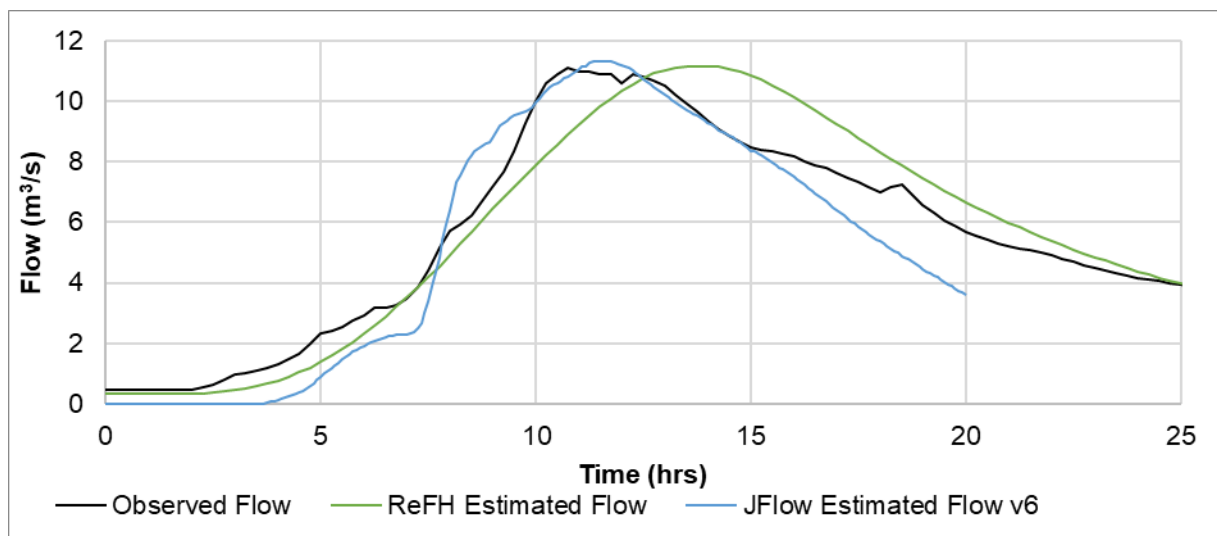
Figure 5-1: A comparison of hydrograph shape from observed flow data at the Slade Brook at Kettering flow gauge and modelled flows from the hydraulic model.

As can be seen in Figure 5-1, the observed hydrograph has a steep rising limb and longer and shallower falling limb. The observed hydrograph shape is relatively wide and round. By comparison, the modelled hydrograph rising limb is slightly steeper than the observed, and falling limb starts at a similar rate of recession but soon becomes steeper than the observed event. This contrast between the modelled and observed hydrograph is likely because baseflow has not been represented in the 2D JFlow model. Inputs from baseflow likely elongate the hydrograph and reduce the gradient of the rising and falling limb in the observed data. The catchment is moderately permeable, meaning there are likely some steady baseflow inputs to channel flows. A simplified approach has been used in the modelling and baseflows are not represented however despite this, there is still a relatively good fit with the observed hydrograph.

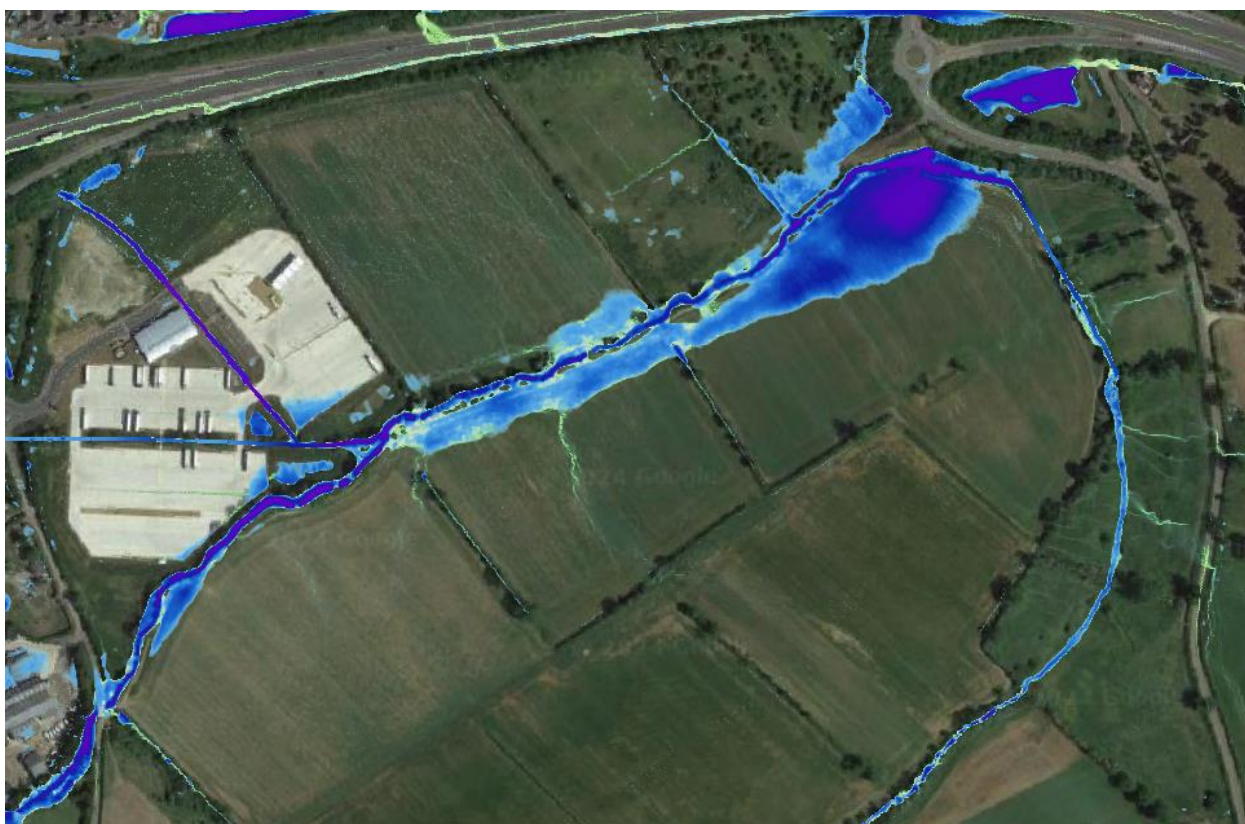
Figure 5-9: Upstream Slade Brook - JFlow Max Flow path analysis for the RP20 event.

South of Rothwell/upstream of A14 shows large potential for floodplain storage or riparian buffer zone enhancement (Figure 5-9). This location is downstream of the confluence between the synchronised upstream Slade Brook and Harrington Drain.

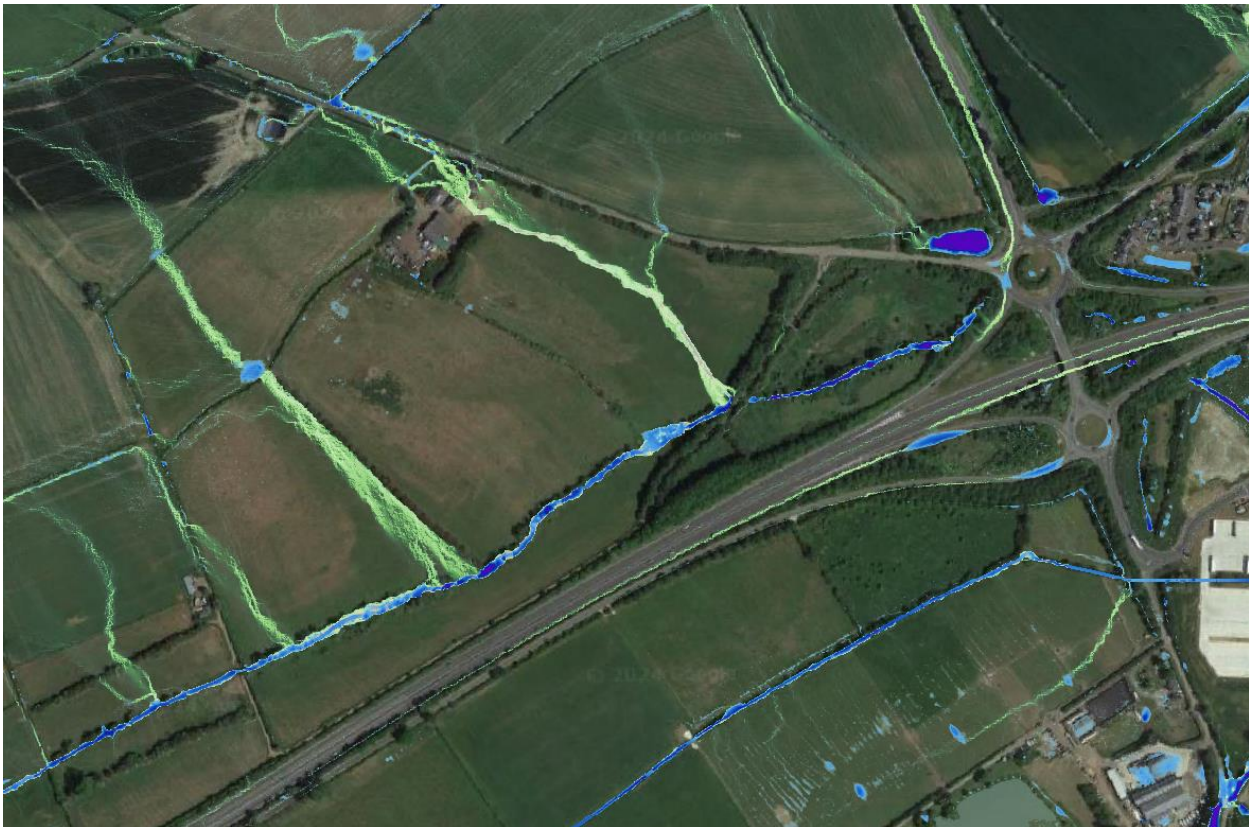
Figure 5-10: Harrington Drain - JFlow Max Flow path analysis for the RP20 flood event.

On Harrington Drain there is potential for leaky barriers or floodplain reconnection upstream of the A14 culvert near Nunnery Farm (Figure 5-10). There is also likely to be inputs into the drain from the A14 and therefore maybe of interest to National Highways for water quality improvements.

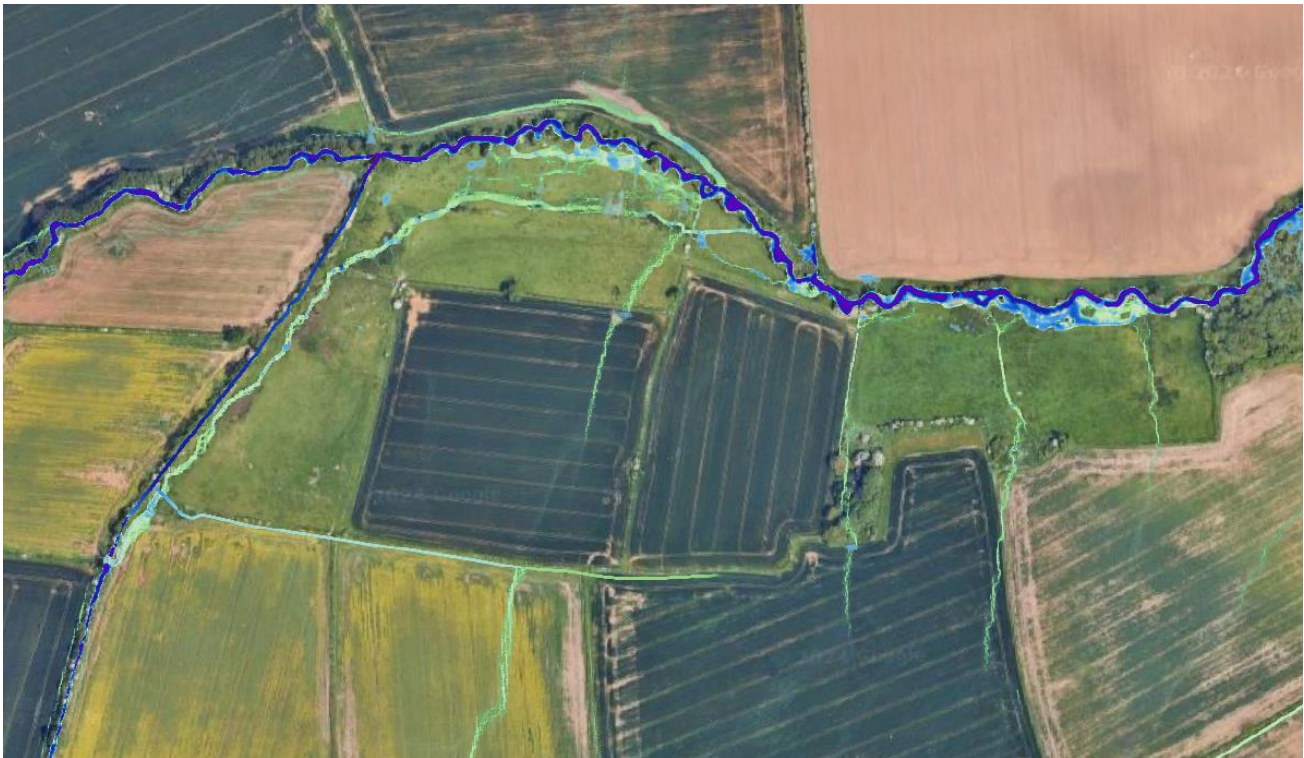
Figure 5-12: Drain upstream of Coppicemoor Spinney - JFlow Max Flow path analysis for the RP20 flood event.

There is also large potential for NFM on land upstream of Coppicemoor Spinney on Coppicemoor Brook (Figure 5-12). The drain in this location has been historically modified and flow path analysis show significant potential for floodplain reconnection.
