Slade Brook NFM

Appendix B - NFM walkover assessment.

Draft Technical Note

March 2024

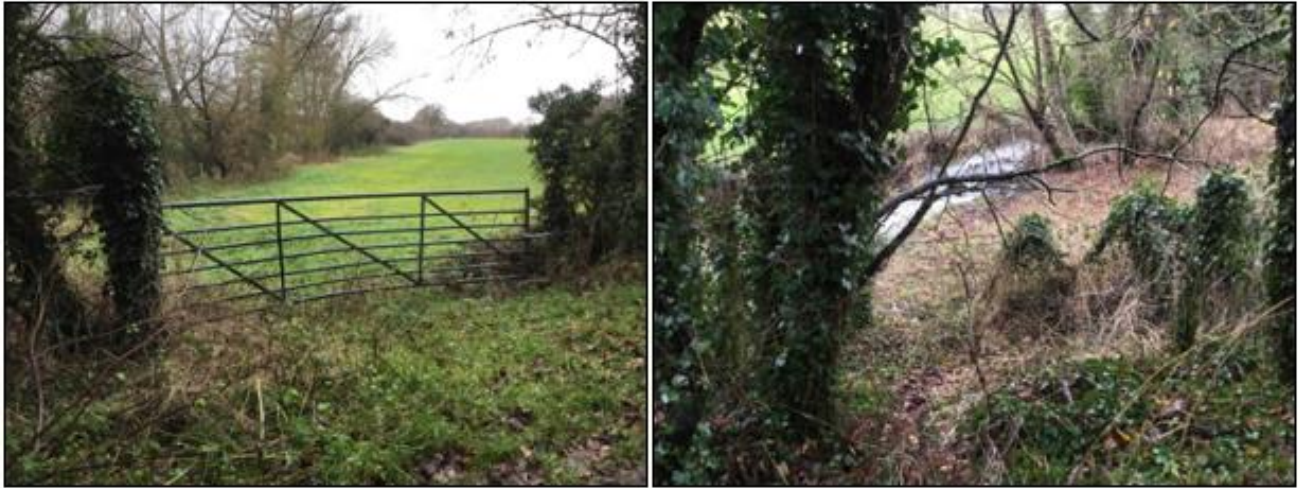
For both visits to site 2, the upstream side of Violet Lane (Figure 1-2), permission had not been granted to access the land. In this upper reach of the Slade Brook, the channel is tree lined whilst running through neutral grassland pasture (Figure 1-3 to Figure 1-4). From the road it appears that the channel is trapezoidal, disconnected from its floodplain and has minimal buffer zone along the right bank. The riparian zone consists of deciduous trees, dominated by Elm *Ulmus* and Willow *Salix* species which line the banks, the banks are short and steep. The fields look like they've been changed from arable to pasture.

Figure 1-3 Standing downstream on Violet Lane looking at the left bank and floodplain of Slade Brook

The valley appears to be very confined, short, and therefore limited for space for a floodplain. However, there could be scope to increase some space for water in the valley and lower the surrounding land in order to create a wet woodland.

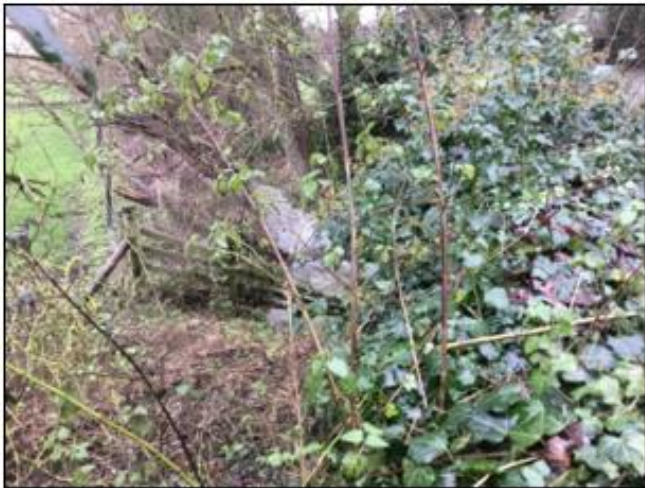
Figure 1-4 Standing downstream on Violet Lane looking upstream at the right bank and floodplain of Slade Brook

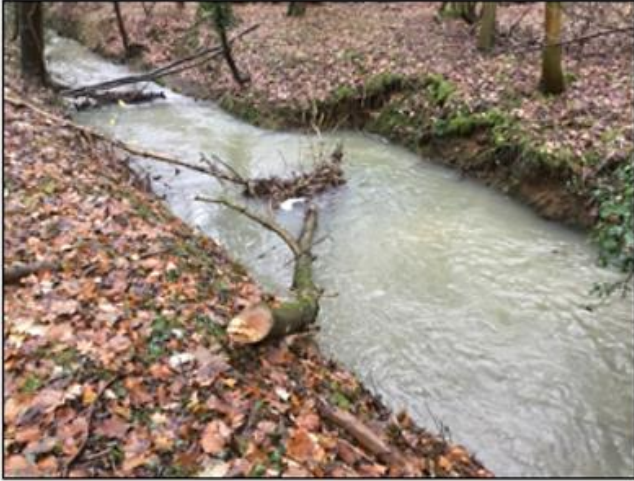
Figure 1-7 Photo location 2, standing on the left bank looking downstream at some woody debris that has been deliberately added by the landowner into the channel (12/12/2023).

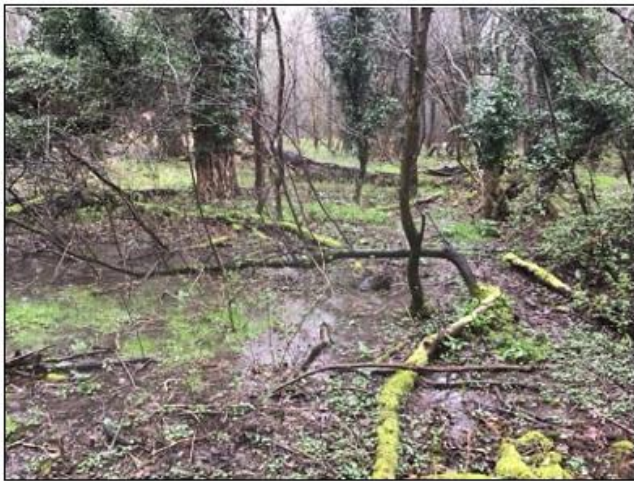
Figure 1-8 Photo location 1, standing on the left bank looking at the floodplain. The floodplain was holding water although it was not clear whether this was water from a recent flood being held back or the result of surface water draining into the floodplain (12/03/2024).

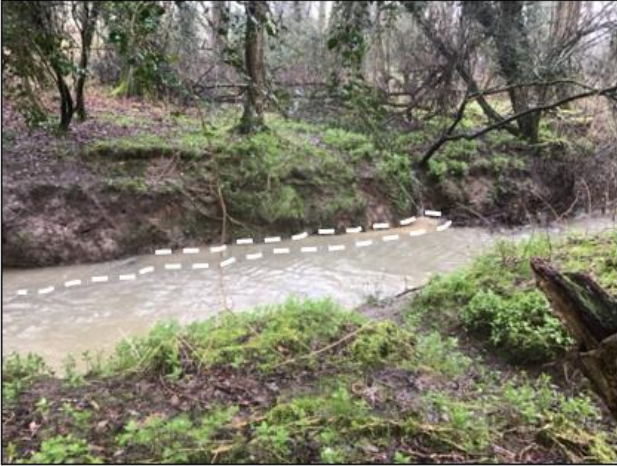
Figure 1-13 Photo location 6, on the left bank looking at a surface water channel draining into the Slade Brook (12/03/2024). The dashed white line emphasises the sediment plume being generated by the surface water flow.

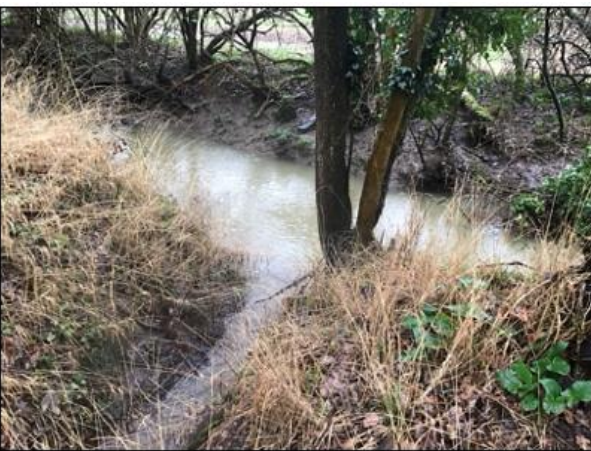
Figure 1-15 Photo location 8, on the left bank looking at a surface water channel draining into the Slade Brook (12/03/2024)

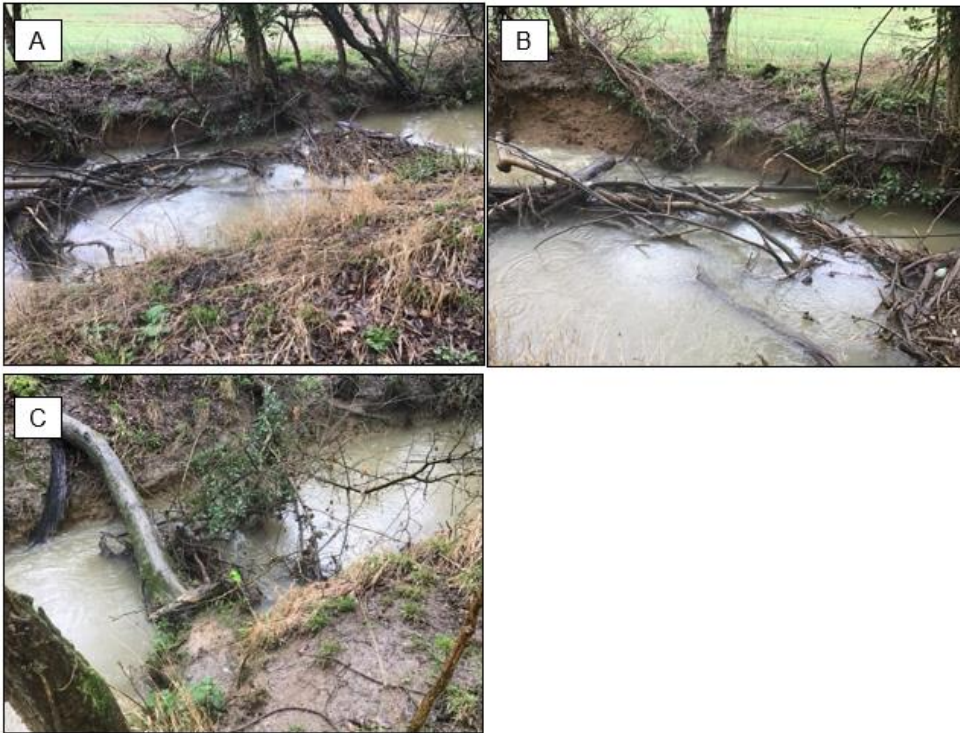
Figure 1-16 Photo location 9, standing on the left bank looking across at a woody debris spanning the channel at multiple locations (12/03/2024)

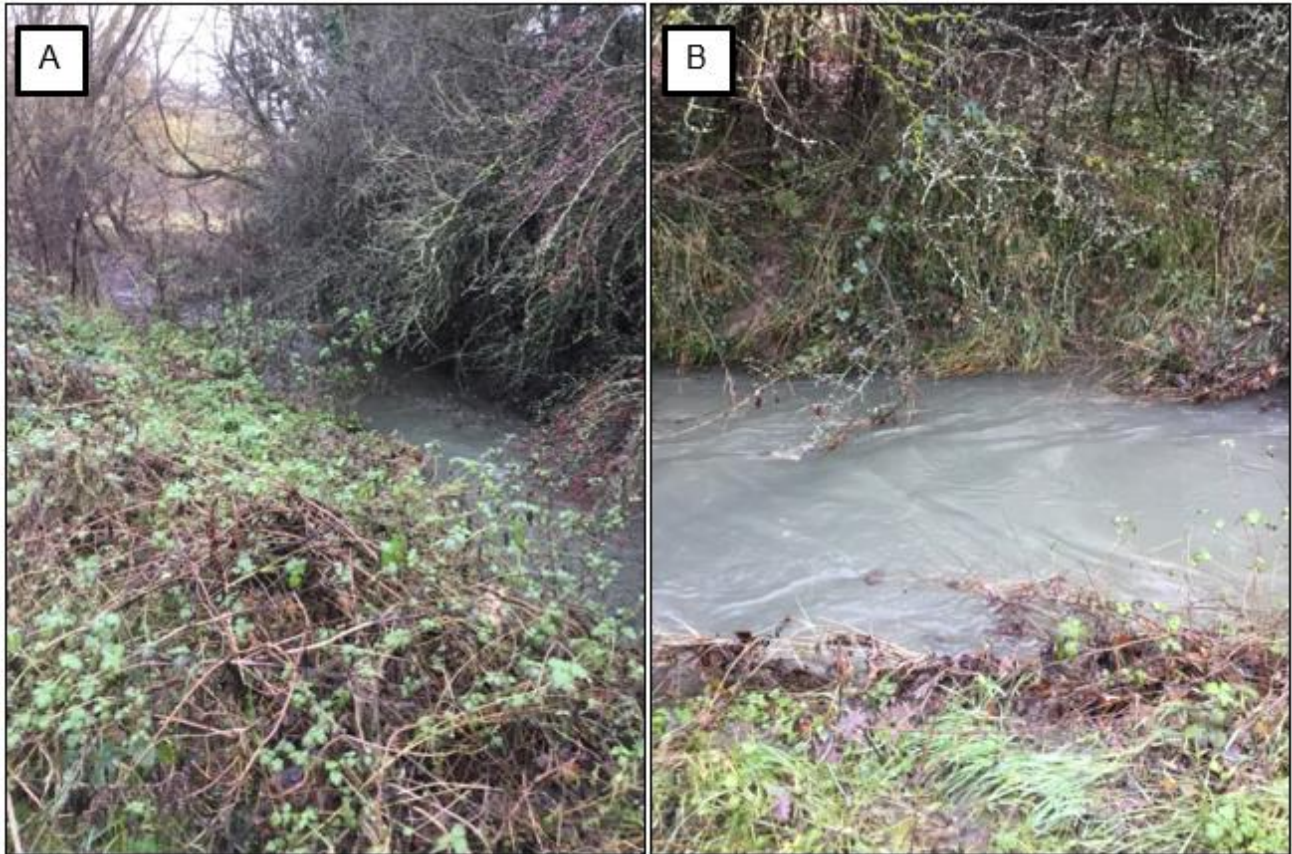
The Linear Park site (Figure 1-18) was assessed on the 12/12/2023 and 12/03/2024 (Figure 1-27). At this site the Slade Brook enters the site via a culvert under the Midland Main Line Railway. At this upstream point of the site (Figure 1-19) the watercourse is confined within a narrow (water width approximately 2m) trapezoidal and straightened channel that is disconnected from its floodplain.

Figure 1-19 Photo location 1, upstream at the outfall of the Slade Brook from the culvert under the Midland Main Line railway (12/12/2023). Standing on the left bank looking A) downstream and B) across. The water was too turbid to see the river bed substrate. The flow was raised due to recent high rainfall.

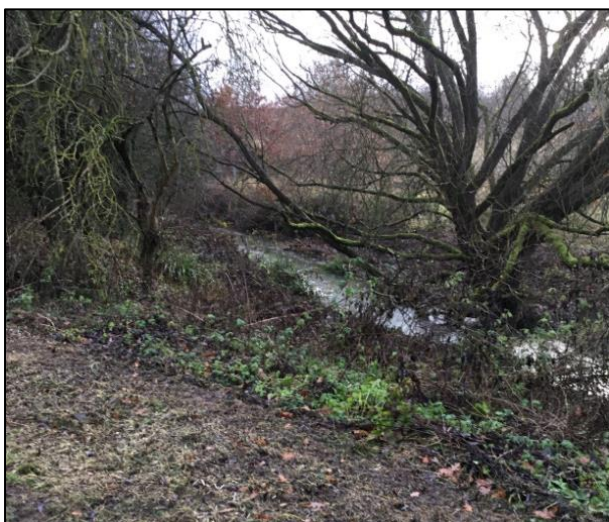
Further downstream at Photo Locations 2, 6 and 8 (Figure 1-20, Figure 1-24 and Figure 1-26) there does appear to be a two stage channel with a berms or benching running throughout the reach. It's not clear whether this is natural or as a result of modification or maintenance. The banks and riparian habitats are suitable for supporting Water Vole.

Figure 1-20 Photo location 2, standing on the left bank looking downstream at the condition of the floodplain and channel (12/12/2023)

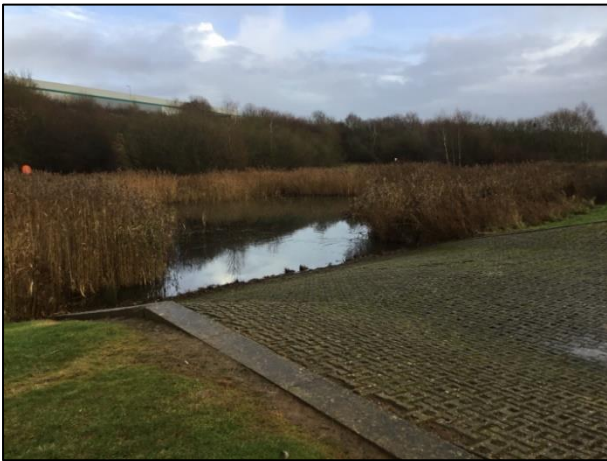
The Linear Park is part of the Prologis Industrial Estate which has a balancing pond to attenuate surface water input from the industrial estate at Photo Locations 3 and 4 (Figure 1-21 and Figure 1-22). The balancing pond can overspill into the Slade Brook via the overflow spill way which passes over the footpath.

Figure 1-22 Photo location 4, the balancing pond for Prologis Industrial Estate (12/12/2023)

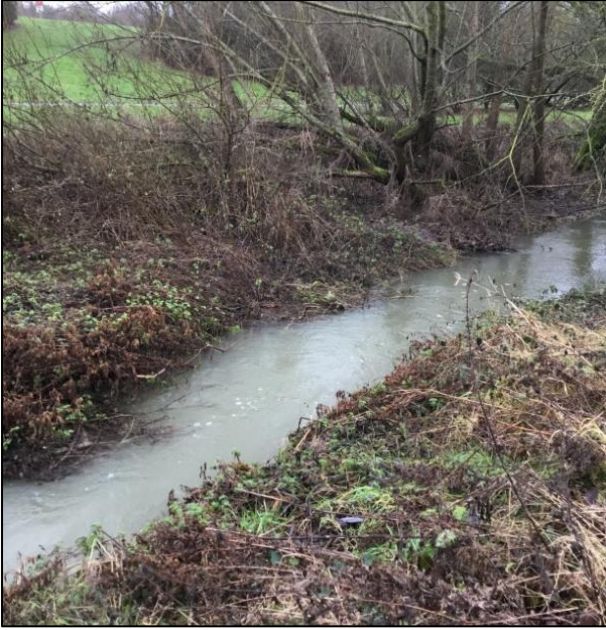
Figure 1-24 Photo location 6, photo was taken on the right bank looking slightly downstream and across to the left bank (12/12/2023)

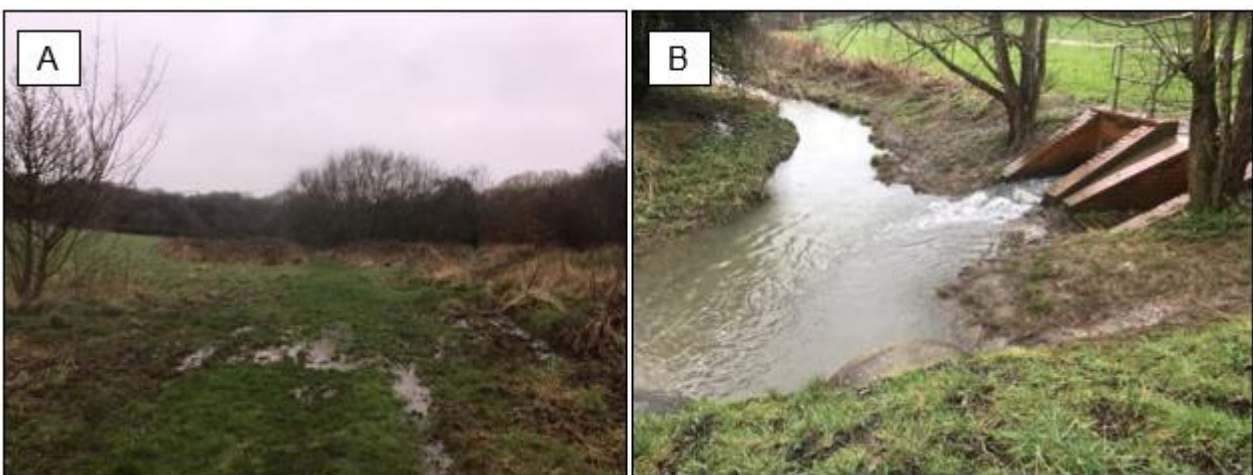
Figure 1-27 During the 12/03/2024 site survey at A) photo location 7, and B) photo location 8. There were no notable changes to the site between the two site visits.

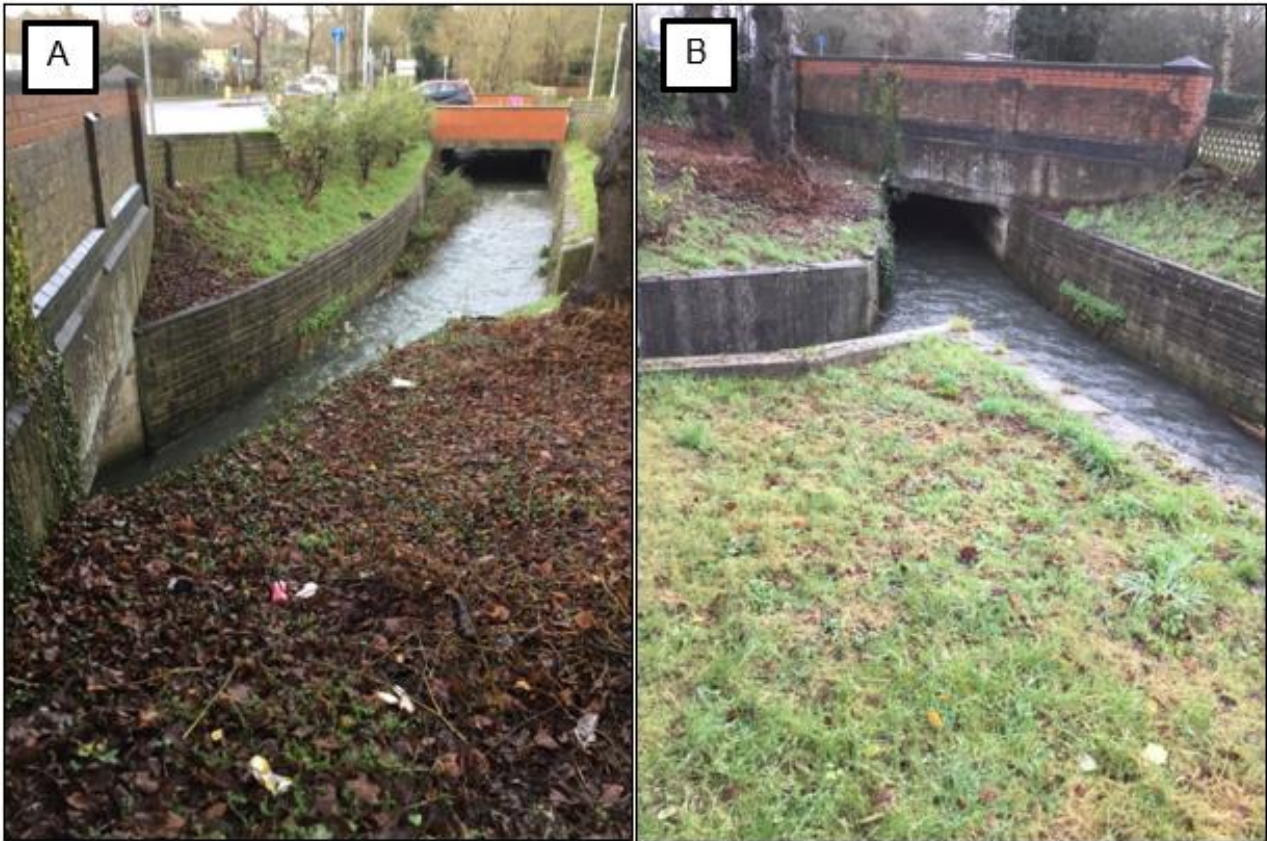
At Meadow Road Park (Figure 1-28) the Slade Brook is deeply confined and incised within a concrete channel on the western boundary of Meadow Road Park (Figure 1-29). At this site there is very limited access to the Slade Brook with only 40m of open channel. Scattered vegetation has begun growing out of the concrete and brick wall banks. It was not possible to see the riverbed substrate due to the turbidity of the water during the site visit.

Figure 1-29 Slade Brook at Meadow Road Park A) standing downstream on the left bank and looking up to the Meadow Road culvert, B) standing upstream on the left bank looking downstream at the Northfield Avenue culvert. A third culvert or outfall enters the Slade Brook which is open up to the fence line in the park

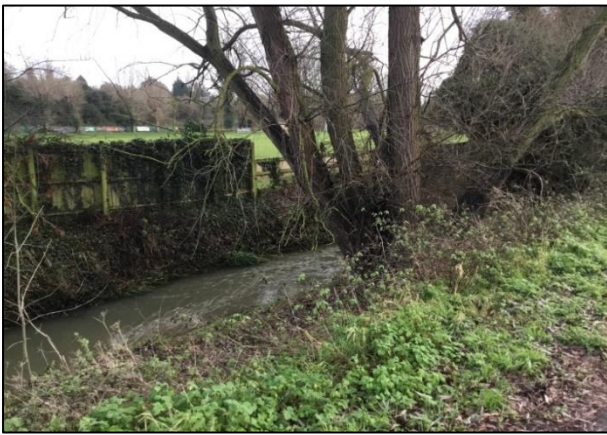
The Slade Brook is incised within a confined channel on the western boundary of Kettering Sports Club (Figure 1-31). The watercourse is confined within a narrow (water width less than 2m) trapezoidal and straightened channel that is disconnected from its floodplain (Figure 1-32 to Figure 1-33). The banks are lined with trees (mainly Willows and Ash) and scrub which interacts with the surface water by trailing into the water and stirring up the surface flow. The flow was a free-flowing run with little diversity. The bed substrate was not visible due to the turbidity of the water during the site visit.

Figure 1-33 On the right bank looking across to the cricket field at Kettering Sports Club

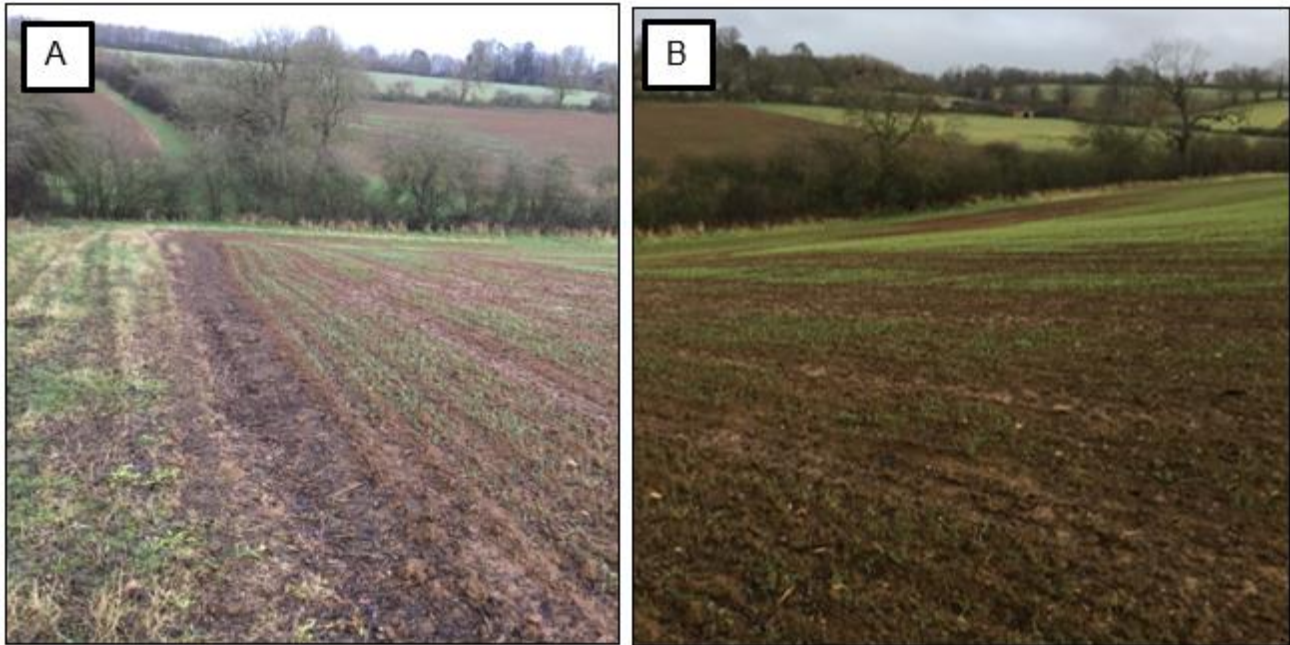
Due to the Thorpe Reservoir upstream, the watercourse only receives a regulated flow which prevents flow diversity downstream. However, due to the landscape, the channel is within a steep valley with little surface roughness due to the ploughed arable fields and not much permanent vegetation or woodland to intercept rainfall and surface water flows. It is possible for flashy floods to occur even with the regulated flow from the Thorpe Reservoir due to the steep and smooth landscape characteristics. It did appear on site that the downstream extent of this watercourse that the discharge was higher than upstream (Figure 1-39), which could be due to the spring (Figure 1-37) and field drainage of the steep valley sides (Figure 1-35).

Figure 1-35 Standing on the right bank on the top of a steep valley looking at the surrounding landscape for the unnamed tributary of the Loddington Arm (Ise)

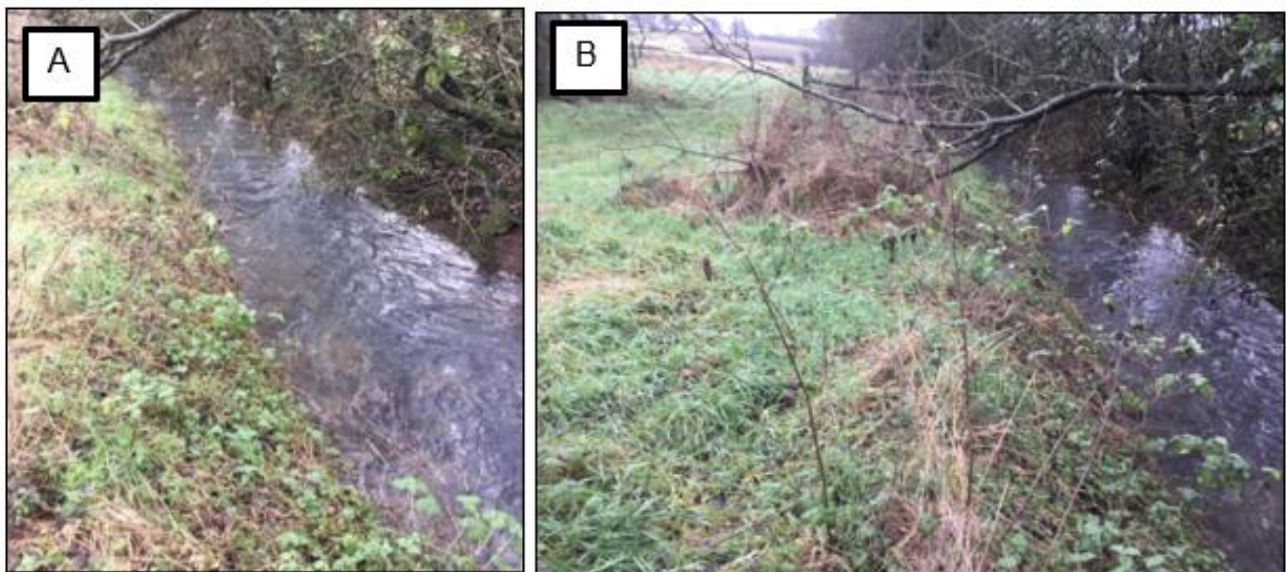
The unnamed watercourse downstream of the Thorpe Reservoir is a tributary of the Loddington Arm (Ise). This watercourse is confined within a steep valley surrounded by Inferior Oolite group, a Jurassic sedimentary rock consisting of limestone, sandstone, siltstone and mudstone (Figure 1-34). The riverbed was mostly visible during the site visit and sediment in the channel consists of sandy patches overlain coarse gravels (Figure 1-36).

Figure 1-36 Taken on the left bank looking downstream. The unnamed watercourse is lined by a hedgerow with mature trees mixed in on the right bank, which provides shade to the brook. The channel is a straightened channel with a farm track and rough grassland running along the left bank. The sediments in the channel consist of patches of sand and coarse gravels.

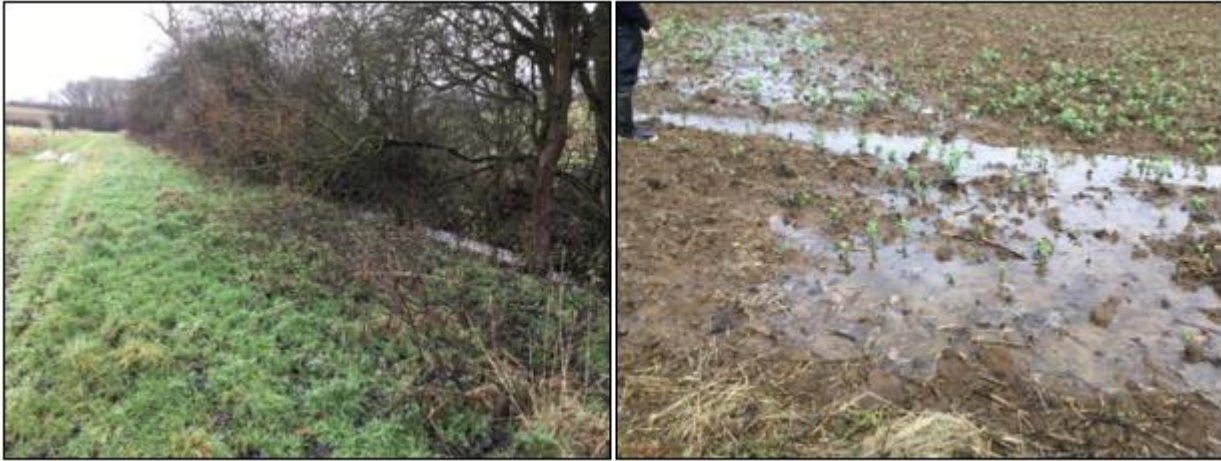
The conditions within the valley floor were wet, with waterlogged locations on the farm track (Figure 1-37 to Figure 1-38) which was likely increased due the presence of a spring. Springs are typical in this Northamptonshire landscape (Northampton Sand Formation) due to the Jurassic Oolite bedrock groups and where the aquifer intersects ground surface. This spring being ploughed and part of the arable field was likely increasing sediment connectivity to the watercourse as sediment movement (erosion and deposition) was visible within the wetted area.

Figure 1-37 The track on the left bank was waterlogged during the site visit with surface water present (potentially from a spring). The hedgerow overhangs the watercourse, potentially overshadowing the channel.

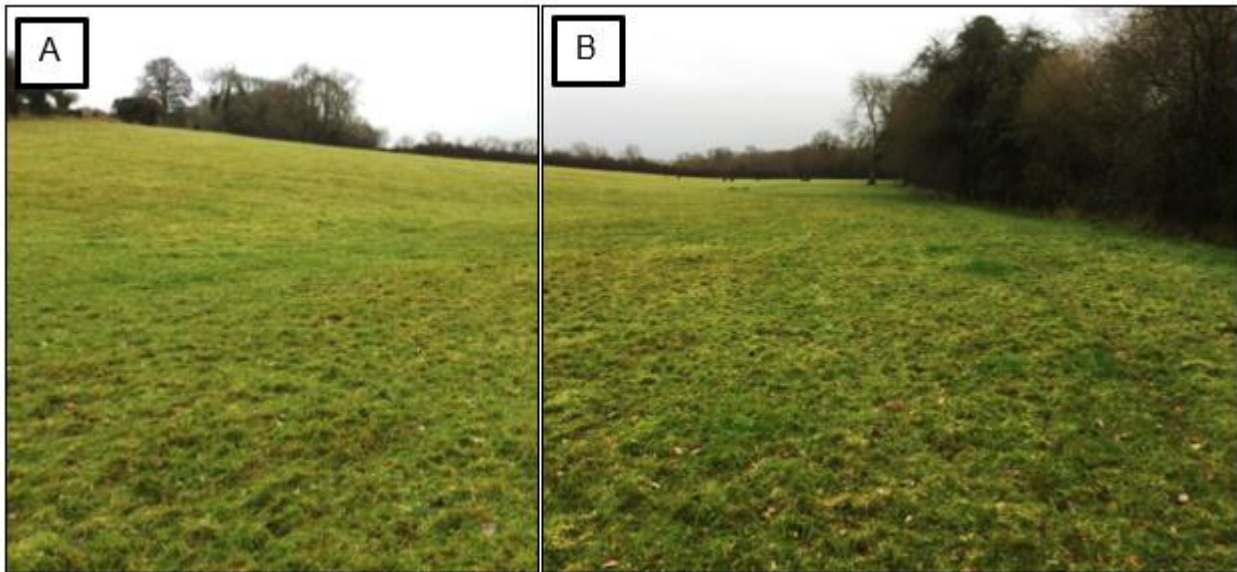
Figure 1-42 Taken on the left bank looking downstream at the floodplain for Loddington Arm (Ise) watercourse. The floodplain is a permanent grassland that is currently grazed by sheep

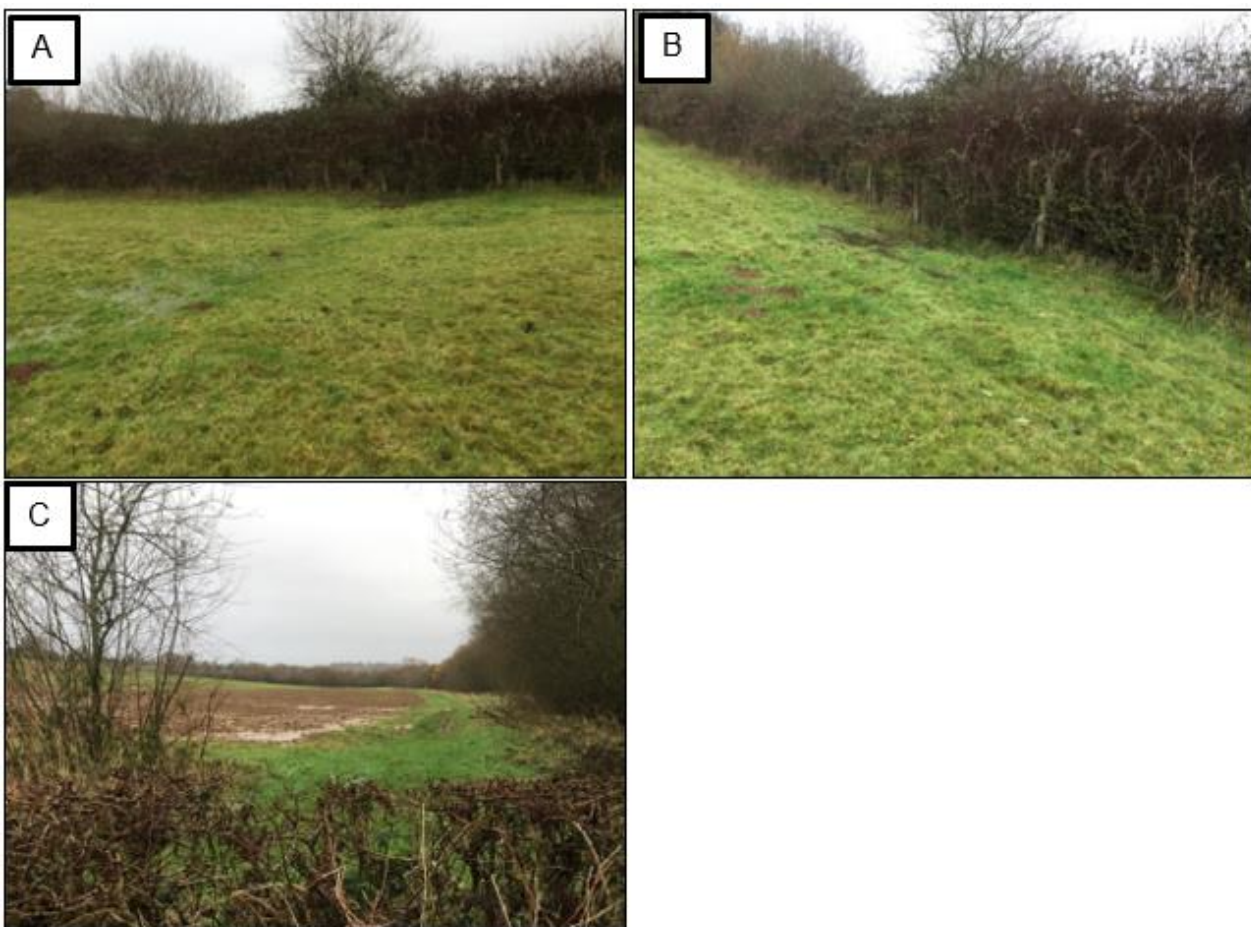
Figure 1-45 A paleochannel channel on the left bank.

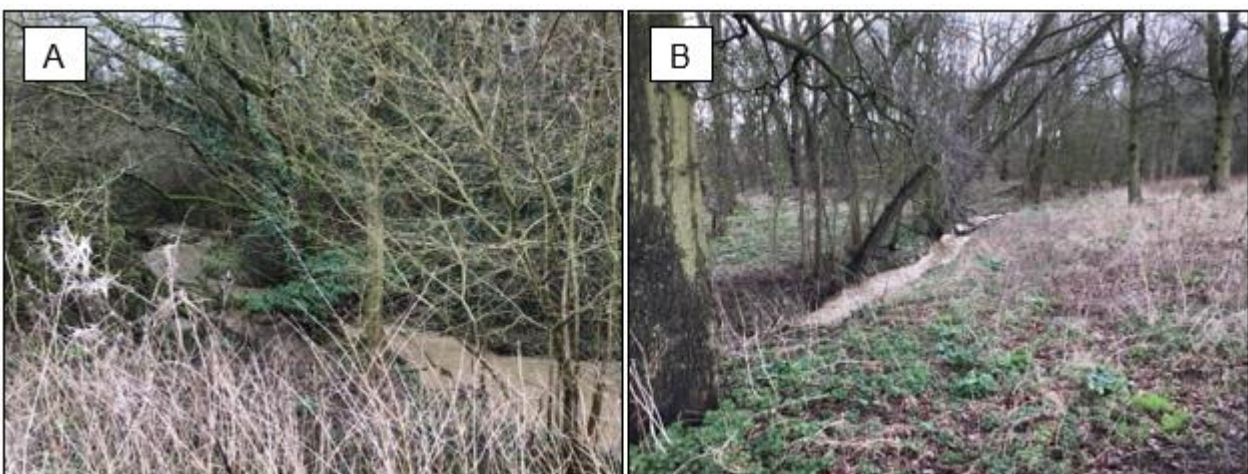
Figure 1-49 Standing upstream on the left bank A) looking upstream and B) looking downstream (12/03/2024).

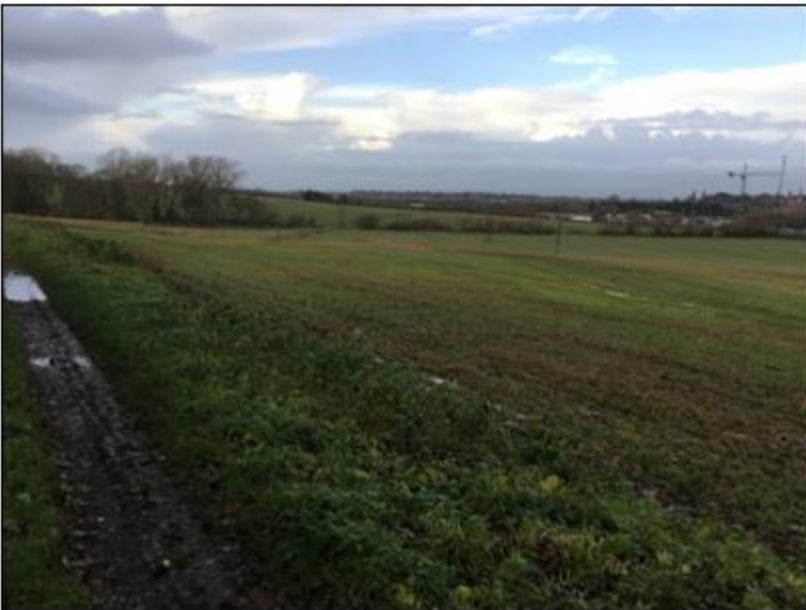
Figure 1-50 Standing upstream on the right bank at surface water draining from the arable field, through the woodland and into the Slade Brook (12/03/2024)

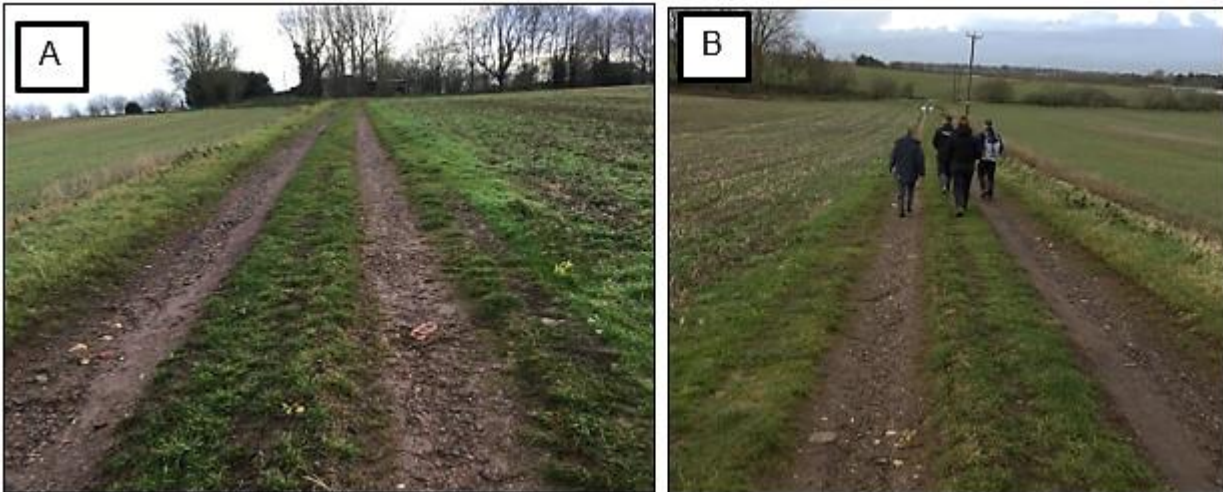
Figure 1-51 Taken on a farm track on a hillslope on the right bank looking towards the downstream extent of the Coppicemoor Brook as it exits the site through a culvert under the A14 (12/12/2023). The Coppicemoor Brook runs through the treeline/hedgerow in the distance.

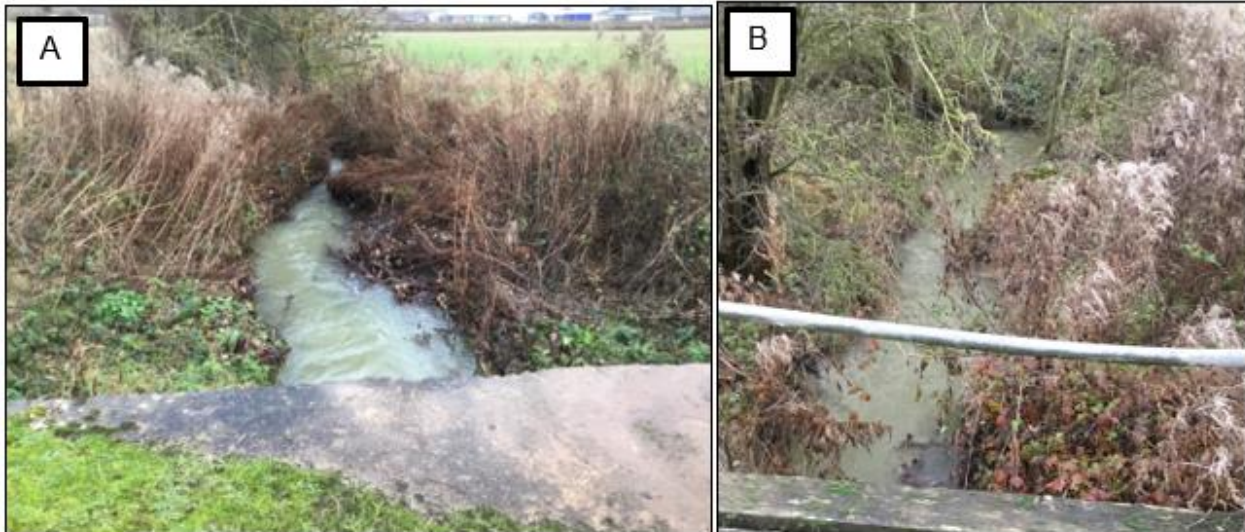
Downstream the tree cover increases and a wider buffer from the arable field is seen on the left bank (Figure 1-55). Woody material has entered the watercourse and some appears to have been left for long enough to begin improving the morphology of the channel by increasing erosion of the banks, which will create sinuosity of the channel.

Figure 1-55 Standing on the left bank looking across A) to a tributary on the right bank and B) at fallen woody debris in the channel which is causing localised erosion and morphological improvements to the channel (12/12/2023)

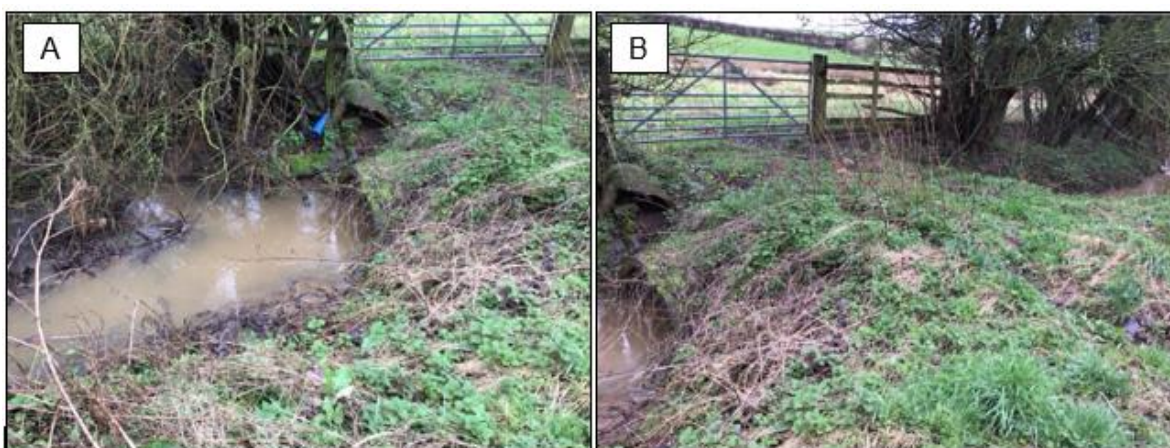
There is another field access culvert at Figure 1-61 which flows freely until it enters the Coppicemoor Brook. Due to the vegetation and the tributary being obscured by the field access culvert at Figure 1-62, it was difficult to see the confluence. The flow of the Coppicemoor Brook was significantly faster than un named field drain with broken and unbroken standing waves. There is a wider buffer strip for the Coppicemoor Brook (Figure 1-63) however unlike the un named field drain, the Coppicemoor Brook is at the valley floor and drained into by steeply sloped, undulating arable fields.

Figure 1-61 On the left bank of a field drain looking at A) the outfall for the field access culvert, B) the entire structure of the field access culvert. In B the field beyond the fence is full of rushes and a potential paleochannel or low relief that is holding water from the flow path seen in Figure 1-61 D

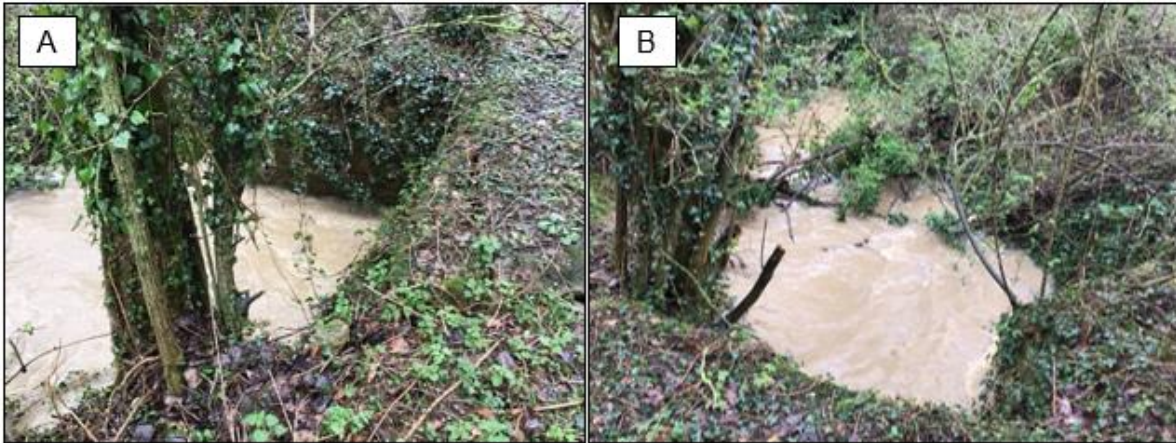
Figure 1-62 A) On the right bank of the Copicemoor Brook looking at the inlet for the field access culvert/bridge, B) on the left bank looking at the outfall of the field access culvert/bridge.

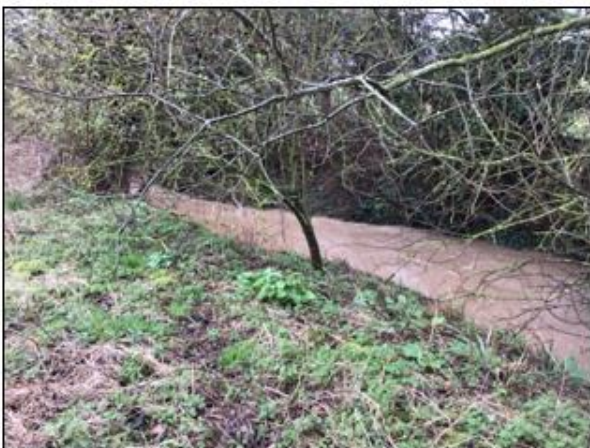
Like the un named field drain, the Coppicemoor Brook at this location appears to be heavily managed, incised and trapezoidal and the flow is flumed through the reach. Looking at the maps, this is the straightest reach of the Coppicemoor Brook within the Coppicemoor Spinney area and conditions up and downstream may differ to this particular location.

Figure 1-64 on the left bank of the Copicemoor Brook looking upstream at the brook.

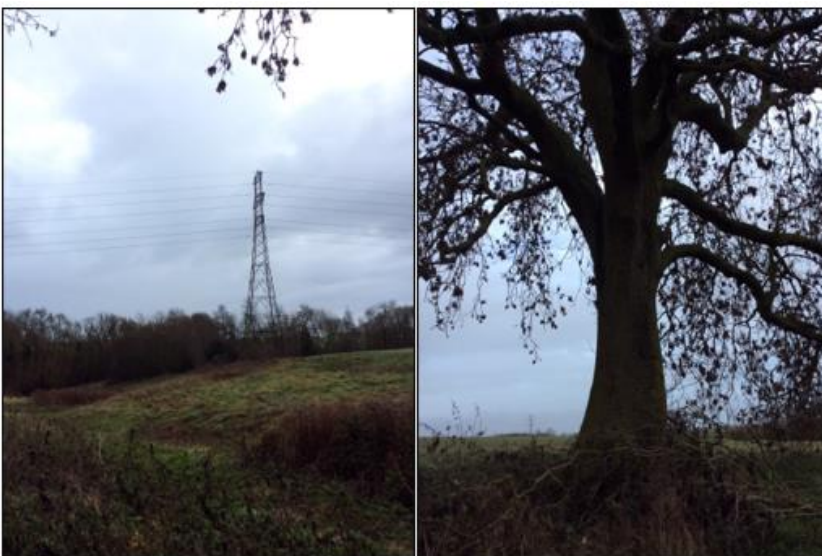
Figure 1-70 Electricity pylons and mature trees to be considered before works are carried out.

There is potential for bunds in the depression in the land to further aid filtering of the water before it enters the watercourse. The 'slowing the flow' process would cause sediment and pollutants and contaminants to be taken out of the surface water flow. Landmarks such as electricity pylons, mature trees and frequently used footpaths need to be surveyed to ensure works could be carried out safely (Figure 1-70).

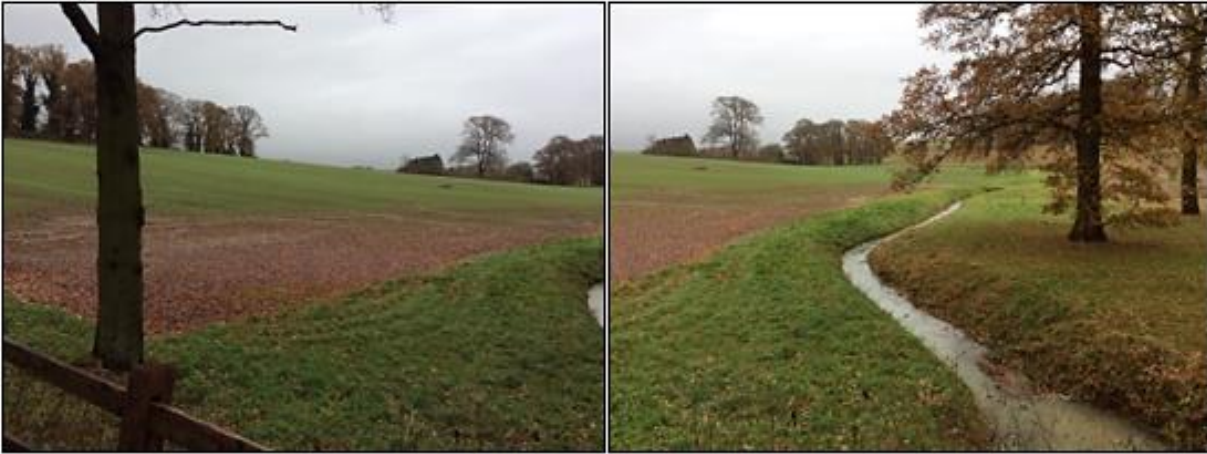
Figure 2-1 Cransley Brook

Cransley Brook is to the north of the town of Broughton. Figure 2-1 shows that there is a minimal buffer at either side of the watercourse. The perimeter of an agricultural field is less than a metre away from the bank top along some northern sections of the watercourse. Ploughing, irrigation and pesticide procedures all undertaken on agricultural land can affect the volume and quality of water entering watercourses. At Cransley Brook, the proximity of the field to the watercourse means there is limited possibility for water to filtered before entering the watercourse. The topography also suggests that the speed in which the water will move in the watercourse could cause backing up and overtopping if the brook cannot cope with flashy events. Tramlines upslope indicate that water and associated sediment and pesticides are likely being funnelled into this watercourse during high rainfall events; should the field be ploughed east to west the flow of water into the water course would be slowed. Soil management and improvement techniques along side improvement to the riparian zone is recommended in this location and is likely to produce significant water quality improvement. Similar signs of sediment/surface water runoff was evident in this location as per Coppicemoor Brook.

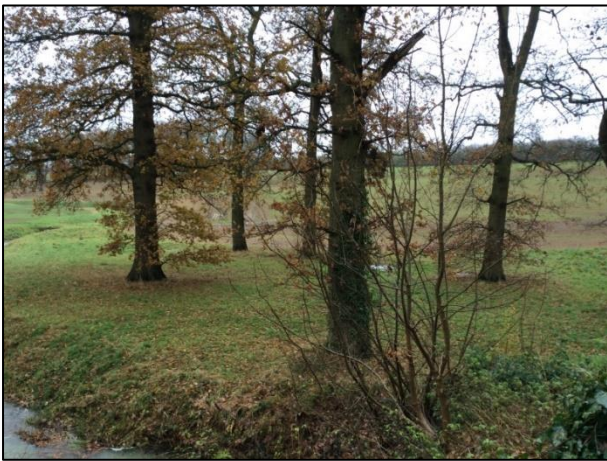
Figure 2-2 Southern bank of Cransley Brook, potential for additional floodplain woodland establishment.

Whilst the southern bank of the watercourse is planted with trees, additional floodplain woodland establishment would be beneficial (Figure 2-2).

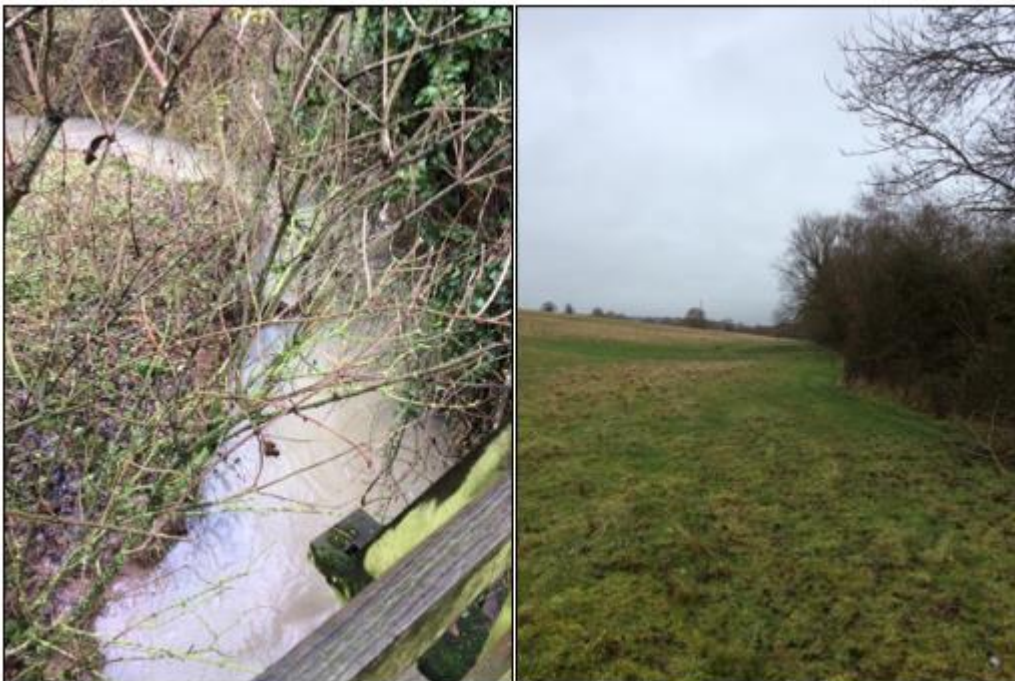
Cransley Reservoir is to the south east of Loddington. Figure 2-4 shows the three sites surveyed in the area. The watercourse at Site 1 is relatively fast flowing, approximately 1.5 metres wide and 1 metre deep. The meandering channel presents opportunities for leaky barriers using local materials from surrounding woodland (Figure 2-5). There is a small floodplain available on the left bank. As a minimum it is recommended to increase the riparian buffer in this location. Alternatively, river restoration or wetland creation could have significant environmental enhancements. The left bank floodplain is currently improved grassland likely used for pasture. There is limited NFM benefit in this location given the proximity of the reservoir downstream.

Figure 2-5 Site 1 watercourse, potential for leaky barriers and wetland/floodplain reconnection.

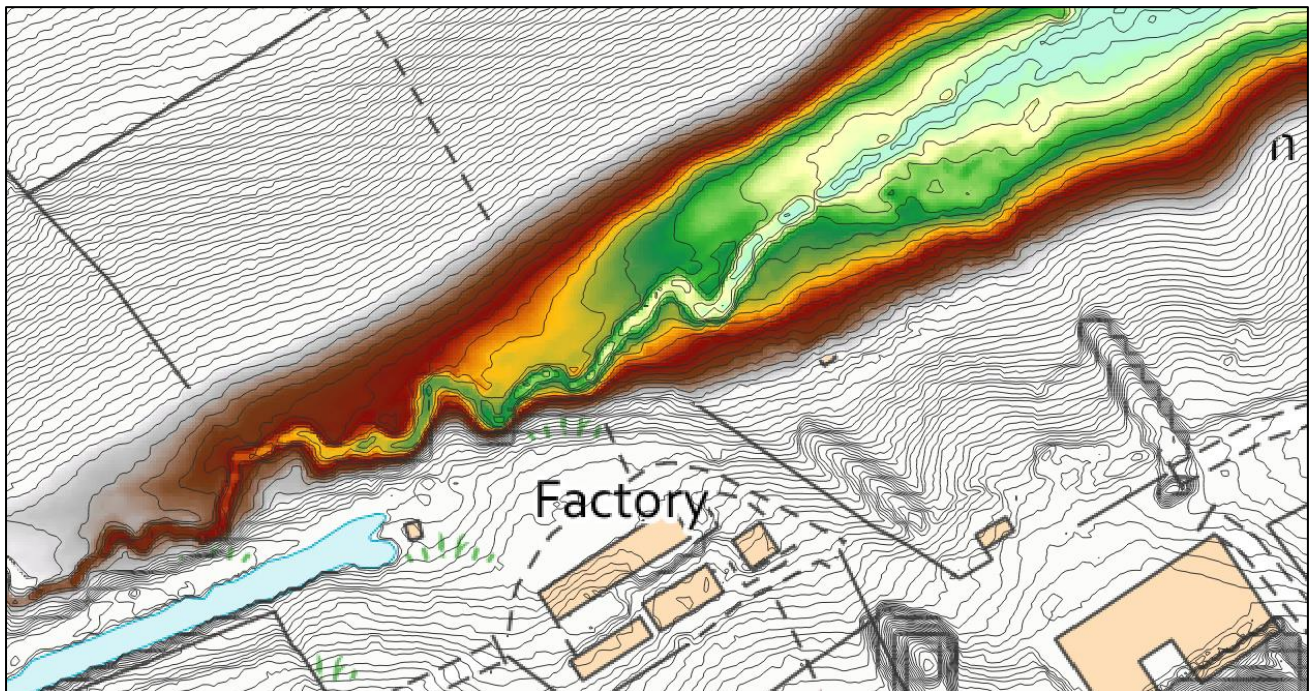
Figure 2-6 LiDAR analysis of Site 1, (Upstream Cransley Reservoir, Southern stream). The floodplain is constrained to 40m. Contours shown at 0.25m increments.

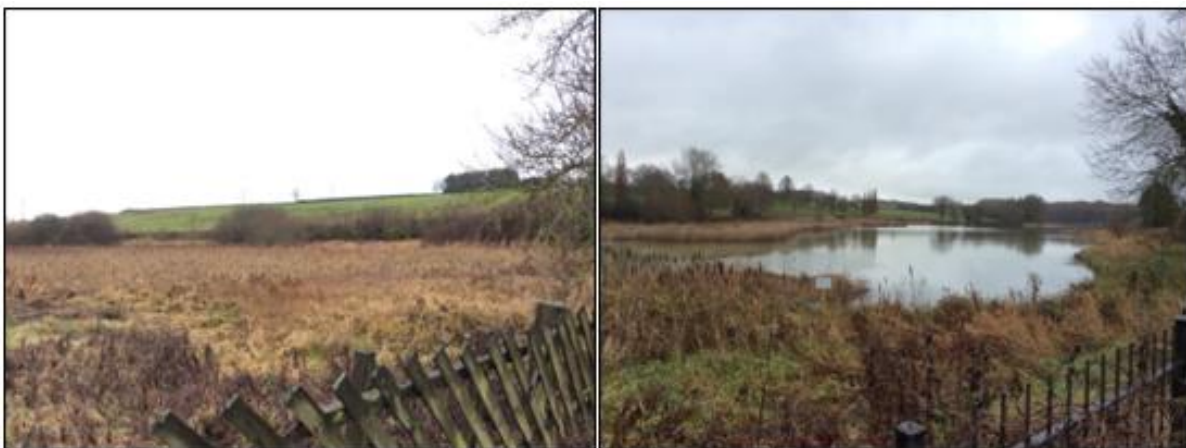
Figure 2-7 Potential for woodland planting (left) to slow flow into watercourse (right)

Site 2 is adjacent to Cransley Reservoir, NFM potential at this site would be woodland planting on the floodplain. This location is probably already done a decent role in environmental enhancement through rough vegetation and floodplain connection. Further enhancement of this area could have significant habitat improvements (Figure 2-7).

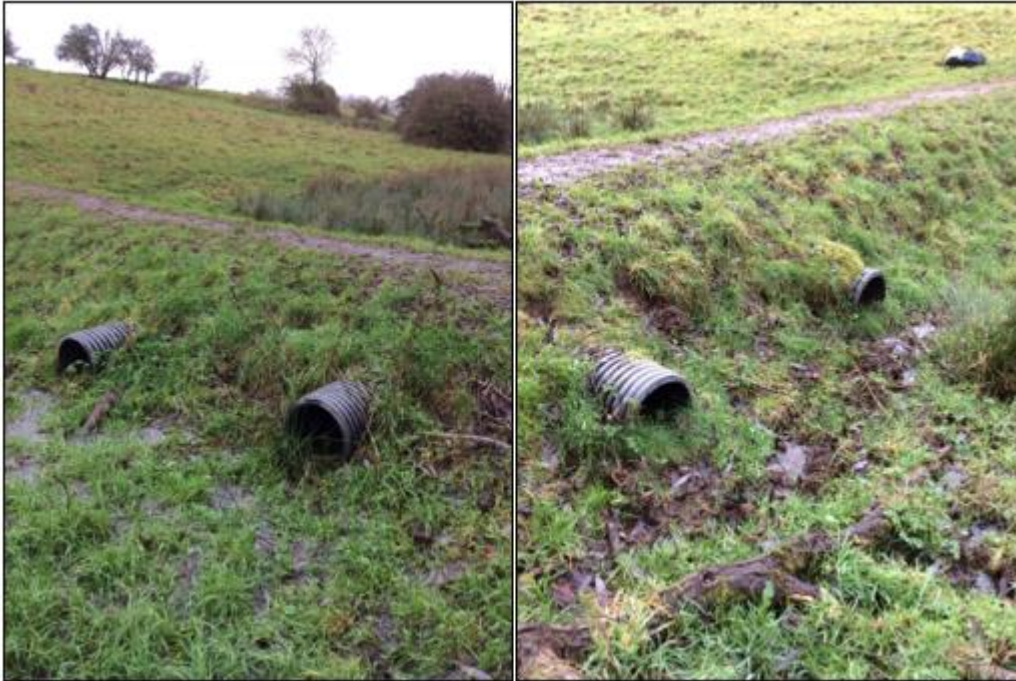
Site 3 is a part of the watercourse stemming from the Northern stream of Cransley Reservoir. Similar conditions were observed at this site to upstream site 1, (Upstream Cransley Reservoir). Although the watercourse is much steeper and floodplain further constrained (20m). There is more potential slightly downstream where the floodplain width increases to 40m. The footpath has been raised and culverted, likely as a result of historic flooding (Figure 2-8). This area could be fenced off to livestock to allow vegetation to

Figure 2-8 Raised and culverted footpath

establish, alongside some additional planting of tree and other native species. Wetlands could also be created along further reaches of the channel, as well as berms and leaky barriers to encourage further floodplain reconnection similar to site 1, (Upstream Cransley Reservoir).
