Slade Brook NFM

Appendix B - NFM walkover assessment.

Draft Technical Note

March 2024

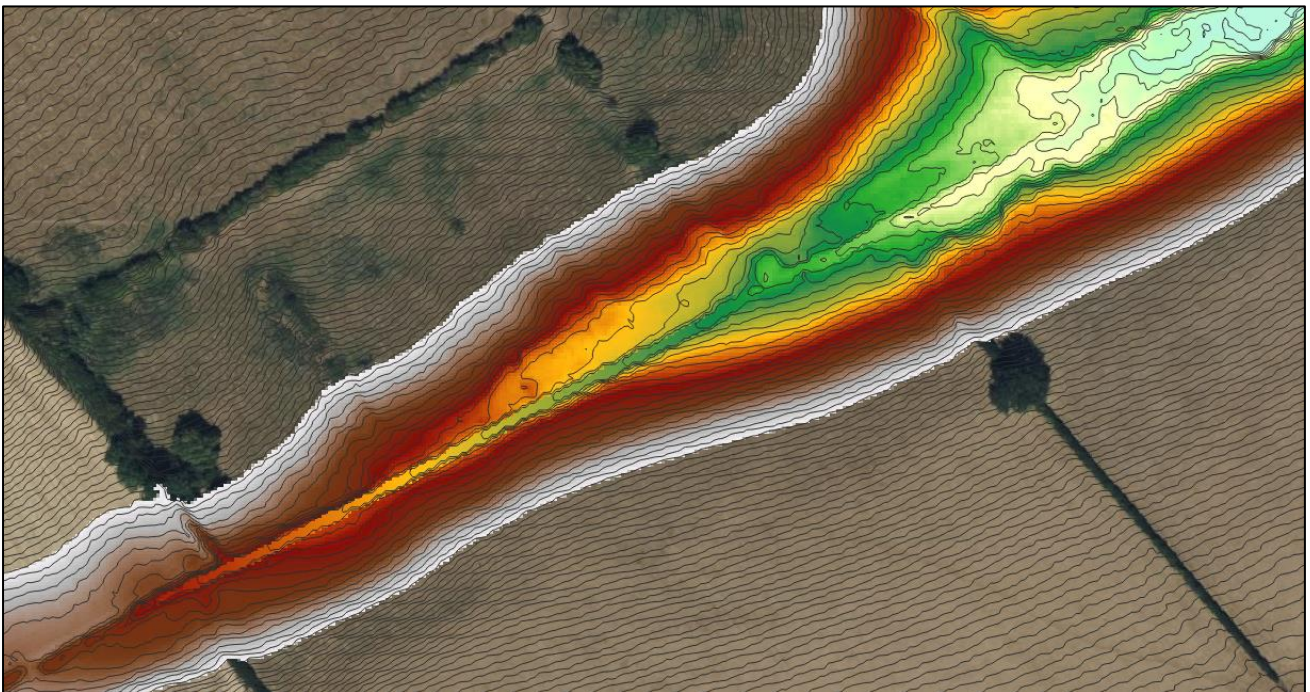
Figure 2-9 LiDAR analysis of Site 3, (Upstream Cransley Reservoir). The floodplain is constrained to 20m. Contours shown at 0.25m increments.

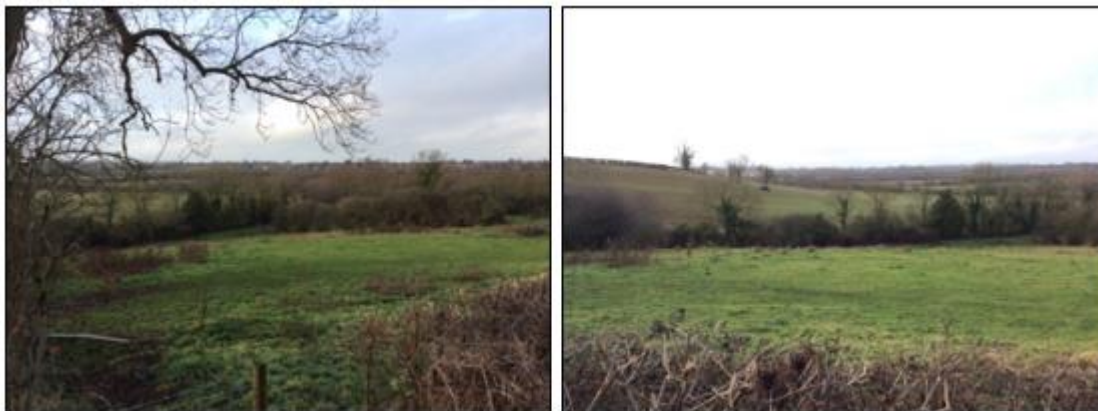
Figure 2-12 Rothwell site, potential for additional riparian floodplain and woodland and wetland planting.

The Rothwell site is to the east of the Slade Brook watercourse (SP 81724 80147), the site is currently improved grassland with some established vegetation. NFM suggestions for this site would be to create some additional riparian floodplain via woodland and wetland planting to slow the flow of water downslope into the watercourse (Figure 2-12).
